# **Rehabilitation of Abastumani Historical Wooden Houses**

## **Environmental Review**

**Third Regional Development Project**

**December 2017**

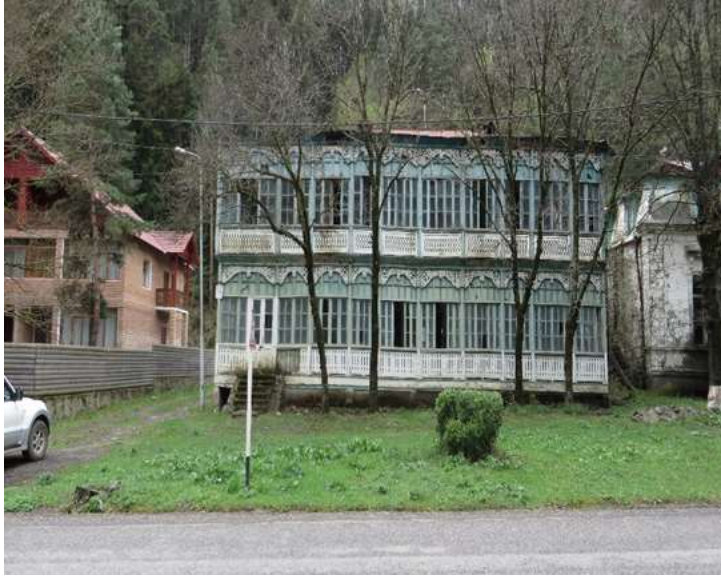
### **Building #56**

The building represents a cultural heritage monument. The house # 56 is two-storied building with three blocks of flats and cellar. The building consists of three connected blocks constructed at various times. Therefore, today they are in different conditions. The front block of flats is

conditionally called an administrative block, middle block is intended for bedrooms and back block of flats represents the dining area. The blocks are connected to each other with glazed loggia. The SP envisages replacement of tin roof, timbering and roofing structures, doors and windows, arrangement of new electronic system, plastering and painting of the walls, arrangement of staircase for cellar. The building will be provided with three entrances; out of which one will be intended for disabled persons. These three entrances will be provided with gable

overhang above the door. Within the SP wooden elements of the façade, gable overhang above the doors, windows and doors will be painted with oil paint. Walls will be plastered and painted with emulsion paint. Interior rehabilitation works include repairing of wooden floor and arranging of a laminated flooring board, electric, sanitary and plumbing system. The whole perimeter of all three blocks will be surrounded concrete drainpipes. Backside of the dining block will be reinforced with concrete wall. Dark grey tin will be used as roofing material.

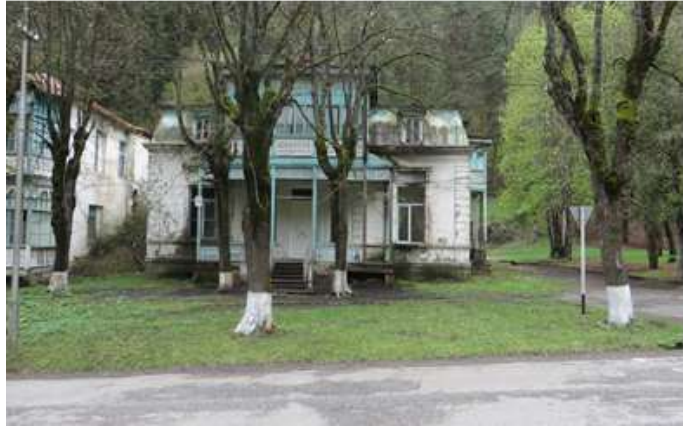
### **Building #58**

The house represents a cultural heritage monument, Russian classical style building, typical to the second half of the 19th century. It is two-storied building with balconies, mansard and basement, which is filled with sand. Adjacent to the northern and western façade of the building, there are construction waste and soil (25 m<sup>3</sup>) that should be removed from the sight.

The SP envisages replacement of masonry constructions, damaged floors and wooden planks of the roof with new ones; Repairing and reinforcement of the basement damaged walls; removal of the soil bulks from the cellar, damaged doors and windows will be changed, wooden constructions, ornaments and curtains will be restored, arrangement of stairs, electric, inner-sewerage system, restoration its wooden elements. Overall perimeter of the building will be surrounded concrete drainpipes. Dark grey tin will be used as roofing material.

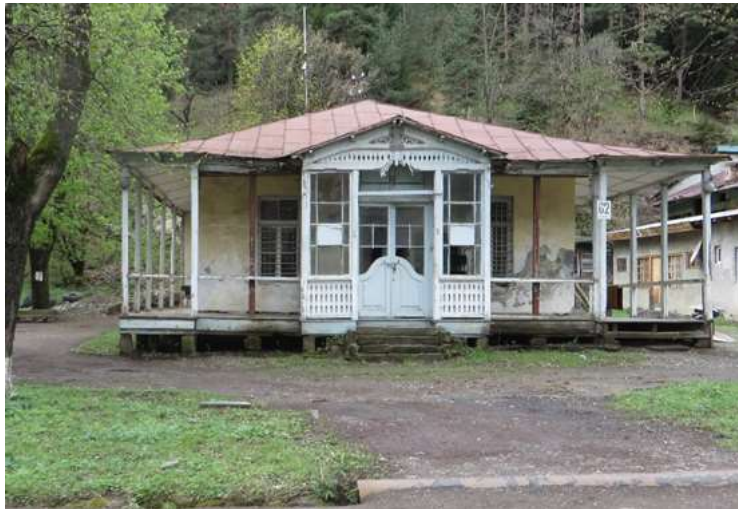
### **Building #62**

The one-storied building is Russian classical architectural style house and typical to the second part of the 19th century. It represents a cultural heritage monument. The SP envisages replacement of tin roof, timbering and roofing structures, doors and windows, arrangement of new wooden floor, railings and pillars of balcony, rehabilitations of the existing stone stairs, plastering and painting of the walls, rehabilitation and painting of the wooden door and installation glasses for porch, arrangement of new wall of the back façade, restoration of decorative wooden pieces. Overall perimeter of the building will be surrounded with concrete drainpipes; Dark grey tin will be used as roofing material.

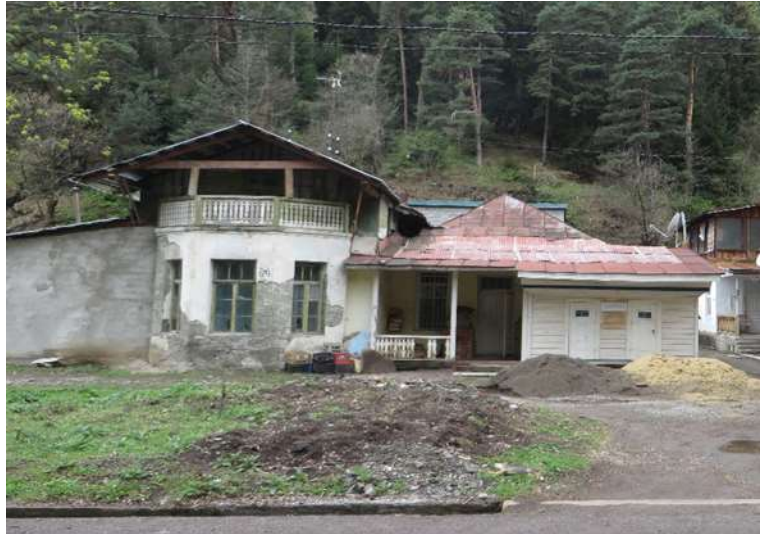
### **Building #64**

The one-storied cultural heritage monument with a mansard is Russian classical architectural style building and typical to the second part of the 19th century. At the north side of the building there is an extension and at the south- wooden one-storied building. Nowadays, the building is in a poor condition, the stairs to the mansard and roofing structure is totally damaged. The SP envisages replacement of tin roof, timbering and roofing structures, doors and windows, arrangement of new wooden floor, railings and pillars of balcony of southern extension, lining of the northern extension with natural stone, rehabilitations of the existing stone stairs, plastering and painting of the walls, installation of new wooden doors and windows, restoration and antiseptic treatment of decorative wooden pieces. Dark grey tin will be used as roofing material.

Damaged details of the wooden staircase at the western side of the facade will be restored and painted. The damaged plastering will be removed from all the facades of the building, covered it with sand-cement mix, and painted.

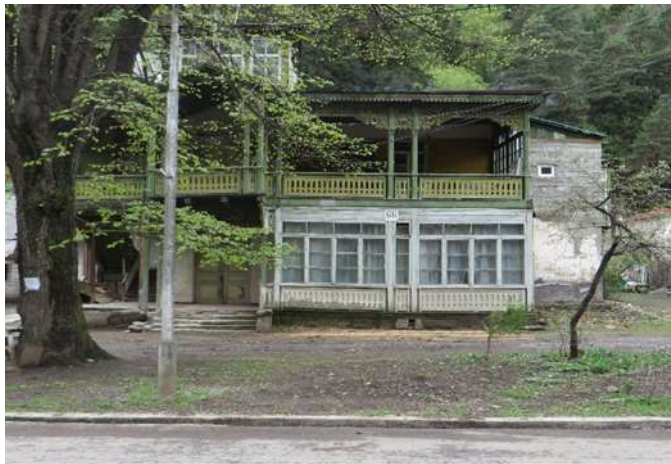
### **Building #66**

The two-storied building represents a cultural heritage monument. It was built in Georgian modern architectural style. The house is not much damaged; it has balconies, two wooden and two stone staircases. The balcony of the ground floor is deformed and requires rehabilitation.

Within the SP, the following works are planned: rehabilitation of stone staircase with basalt stone, repairing of the wooden staircase steps, demolition of the existing roofing material and wooden structure, windows and doors, floor of the balcony, plastering and painting of the walls, replacement of balconies pillars, rehabilitation of balconies railings and restoration of decorative wooden items.

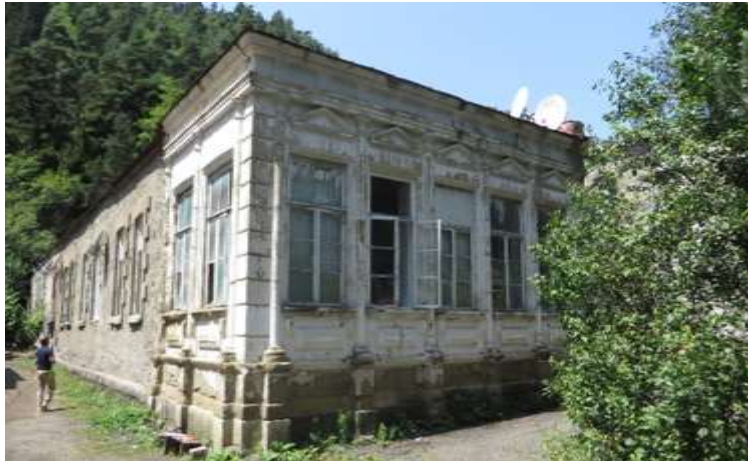
### **Building #68**

The building represents a cultural heritage monument and at the same time Russian classical-style architectural structure, typical for the second half of the 19th century. The one-storied building is the best example of stone architecture. The north and south façades of the building are much damaged and require restoration. At the northern façade, there must have been a wooden balcony, which was altered later as a room. At the western façade, there is a wooden balcony, which is in a poor condition. From the backside of the building, there is a small slope, which poses a threat to the house, thus the SP envisages construction of concrete wall to avoid falling of stone.

The rehabilitation works of the building include demolition of the existing roofing material and its wooden structure,, replacement of balconies pillars, rehabilitation of balcony railings and restoration of decorative wooden items, arrangement of new staircase with basalt, lining of the house with natural stone are planned.

The facades will be cleaned from the paint, restoration of damages created from the pulled stones that will be filled

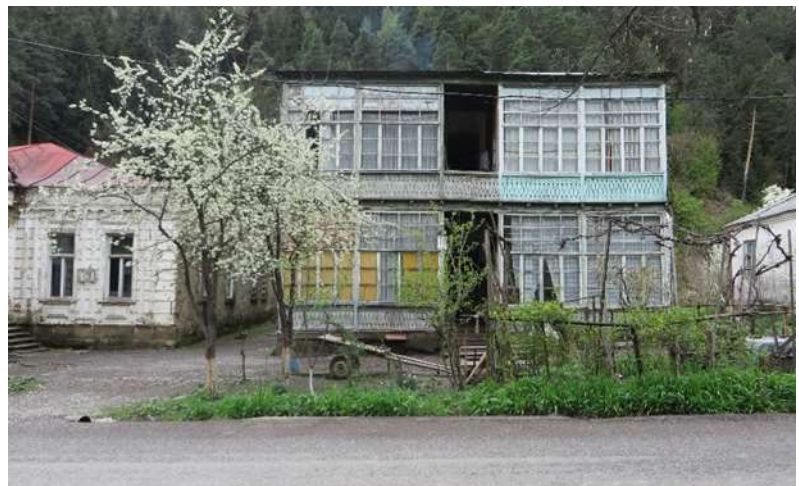
The two-storied local stone building represents a cultural heritage monument and at the same time Russian classical-style architectural structure, typical for the second half of the 19th century. It has glassed wooden extension from the front facade, with ornamented décor theme. Nowadays, the house and its foundation is in a good condition and require just restoration works.

The SP envisages demolition of the existing tin roof and its wooden structure, wooden windows and doors, amortized wooden covers of the front façade and wooden stairs. Within the SP, the following exterior restoration works are

planned: arrangement of new roof with dark grey tin, lining of socle with basalt, painting of wooden details of the facades with oily paint, arrangement of new basalt staircase instead of wooden one, rehabilitation and painting of metal stairs with anticorrosive paints, replacement of damaged decorative wooden pieces and column with identical ones.

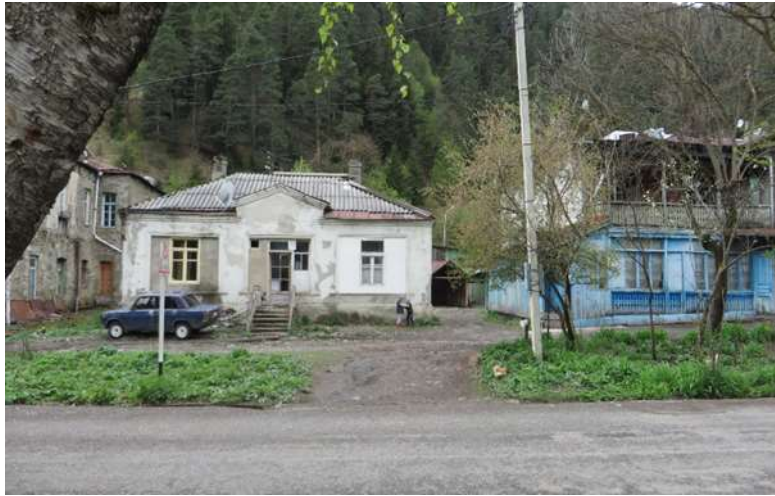
### **Building #72**

The one storied stone building # 72 is Russian classical architectural style structure typical to the 19th century. The house has been provided with asbestos containing roofing materials. It seems

the house was altered several times. Under the presented SP the following works are planned: demolition of asbestos containing roofing, wooden amortized windows and doors, plastering of stone walls with sand and cement mortar, lining of socole and stairs with basalt tiles, installation of new wooden windows and doors, providing of staircase with metal railing and arrangement of new roof with dark grey tin.

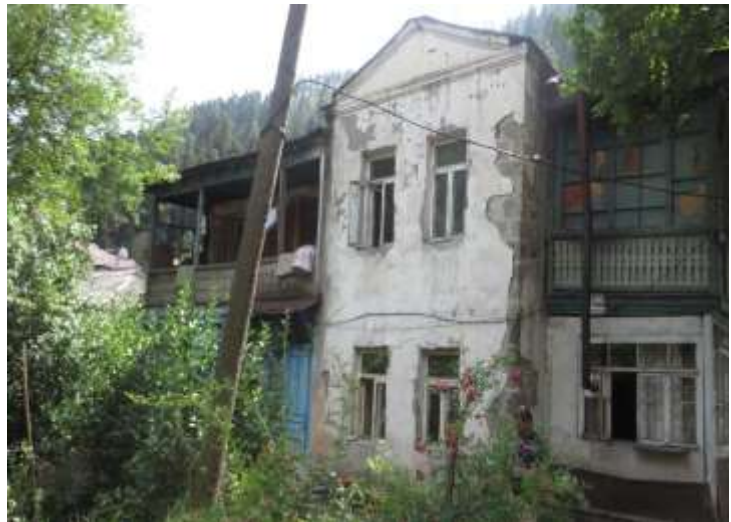
the SP, the following works will be carried out: demolition of the exiting tin roof, timbering and roofing structures, doors and windows, amortized floor of the balcony, arrangement of new roof with dark grey tin, plastering of the walls with sand-concrete mortar painting them with watercolor paint, lining of socole with basalt, painting balconies with oil paint, restoration of wooden decorative items, wooden railings of balcony and painting them, arrangement of stairs with basalt, installation of new wooden windows and doors. Deformed details of the balconies

will be repaired, damaged parts changed and restored its original appearance.

On the first floor of the northern facade, a new glass loggia, similar to the one on the second floor, will be installed, staircase and second floor balconies will be repaired, and damaged strengthened and fixed.

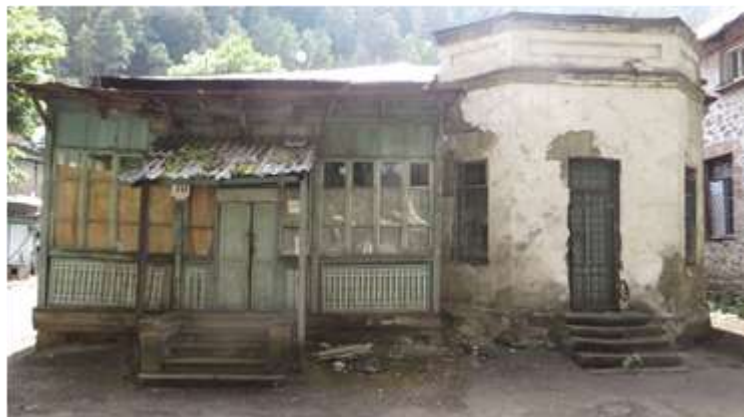
### **Building #78**

The one-storied building # 78 is also a cultural heritage monument, typical for the second half of the 19th century. Under the SP, the following works will be carried out: restoration of glazed loggia, wooden decorative items, the existing stairs, construction of new balcony of the glazed loggia, demolition of existing roof and arrangement of new one with dark grey tin, plastering of the walls with sand-concrete mortar and

painting them with watercolor paint, lining of socle with basalt, arrangement of new decorative wooden railings of balcony, painting of wooden covers and decorative pieces of the façade with oil paint, dismantling of the existing metal lattice of the door and windows.

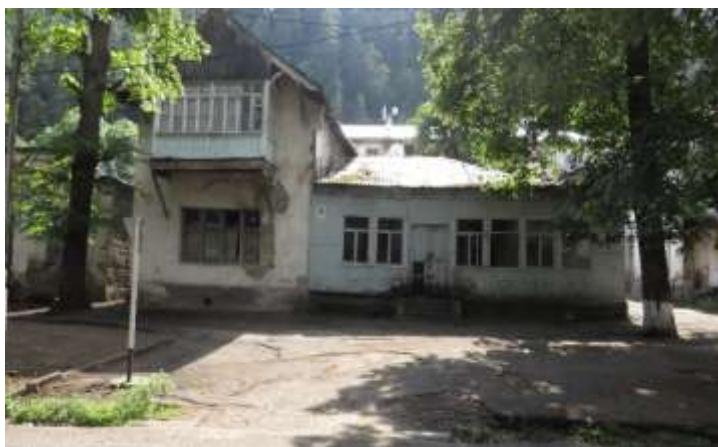
demolition of asbestos containing roofing material and the existing tin roof, amortized wooden floor, windows and ceiling of balcony, arrangement of new roof with dark grey tin, plastering of the façade with concrete and painting them with watercolor paint, rehabilitation and restoration of balconies and glazed loggia, installation of new windows and doors, restoration of wooden decorative pieces and painting them. The western side of the building will be plastered and painted with emulsion paint of façade. Gable of balcony coming out to the street side will be renovated.

The second floor of wooden balcony will be restored and fortified with new columns.

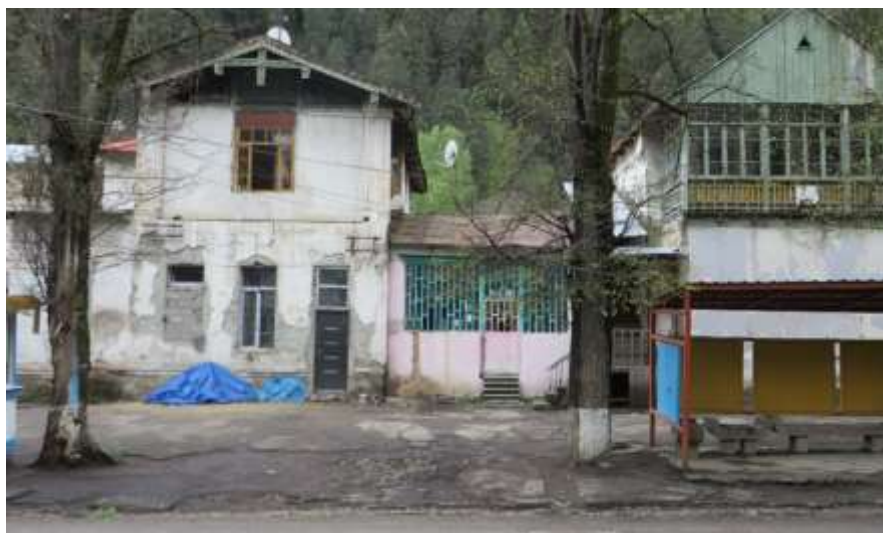
The houses are built in Russian classical architectural style typical to the second half of the 19th century. The two-storied stone building #84 represents a cultural heritage monument. It has two entrances, gable with decorative wooden pieces. The SP envisages replacement of front façade glazing, restoration of glazed loggia, arrangement of new roofing with dark grey tin, plastering of walls and painting them, restoration of decorative wooden pieces and rehabilitation of the existing staircases, installation of new windows and doors.

The building # 84 is connected to the building # 86 with later built extension. The storied building has glazed loggia from the front façade, it is plastered and painted. Under the SP, the following works will be implemented: arrangement of a new roof with dark grey tin, plastering of the facades with san-concrete layer, installation of wooden windows and doors, rearrangement and restoration of wooden decorative items, arrangement and rehabilitation of the existing stairs.

The existing glass gallery and planked fronton from the street side of the building will be restored, staircase rearranged, a deformed construction of the balcony at the end of the northern façade will be strengthened. On the connecting part of these two houses, the metal stained glass will be dismantled and a glass gallery, similar to the house #86 will be arranged.

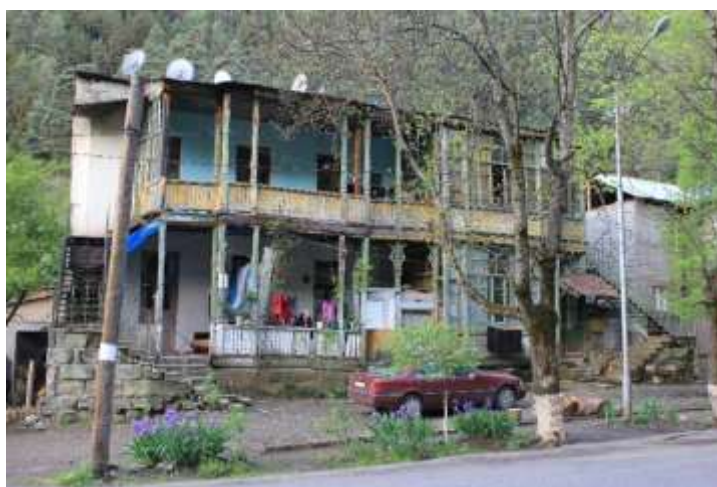
### **Building #94**

The two-storied building is a cultural heritage monument. The house is provided with wooden balconies and glazed loggia that are much damaged requires strengthening. From the western façade of the building, there is also a wooden balcony and an extension. The SP envisages dismantling of amortized roof, windows, doors and floor; arrangement of new roof with dark grey tin; installation of new wooden windows and doors; plastering of facades with concrete, painting them, lining of socle with basalt; arrangement of new wooden floors and ceilings for balconies; rehabilitation of metal stairs and arrangement of railing for them, restoration of decorative wooden pieces, lining of stairs with basalt.

Masonries of northern and southern facades will be renovated. Balcony of northern façade from the inner yard will be completely rearranged, its initial look will be restored.

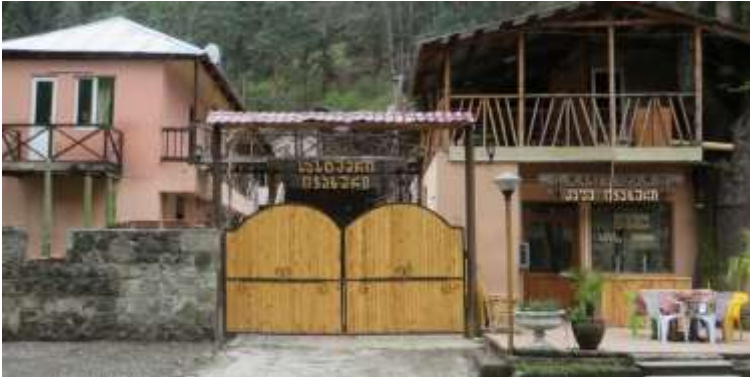
**Building # 96**

The building #96 represents a guesthouse and open terraced café. The SP envisages dismantling of amortized wooden gate and granite floor of terrace, painting and lining of wall with natural stone, arrangement of wooden decorative ornaments, wooden railings, shady for terrace, new wooden gate and railings for balcony.

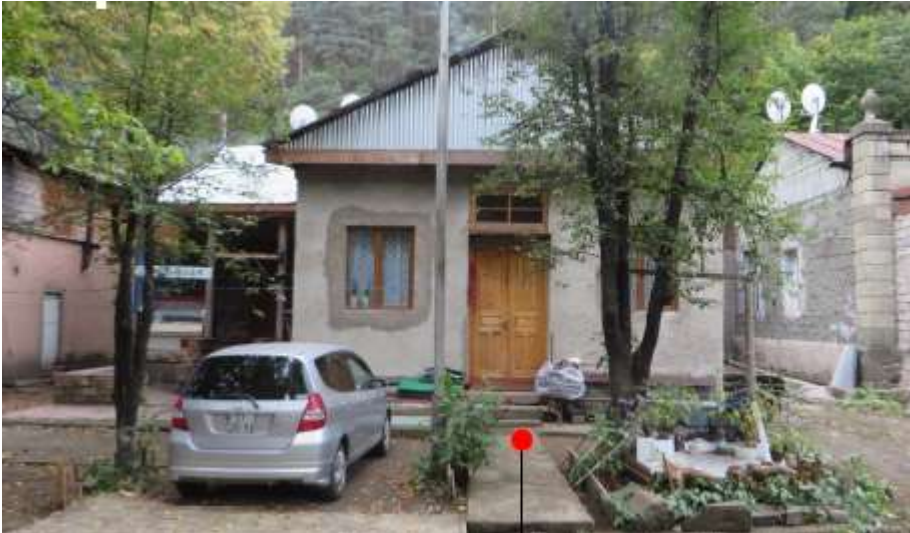
**Building # 98**

Within the SP, the following works are planned: dismantling of amortized tin roof, fronton and stairs, arrangement of a new roof with dark grey tin and a new wooden fronton, wooden pillars and railing for balcony, wooden shutter plastering and painting of front façade, lining of the front stairs with basalt, arrangement of wooden shutter and flowerbeds for windows.

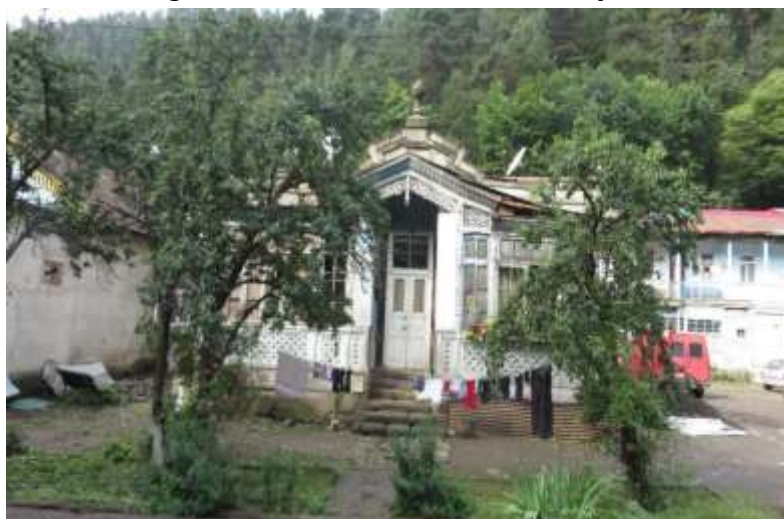
**Building #100**

The one-storied house represents a cultural heritage monument. From the front façade, there is a wooden glazed loggia, with decorative pillars and a wooden fronton, which requires rehabilitation. The building is roofed with asbestos containing material.

The SP envisages demolition of asbestos containing roofing materials, arrangement of a new roof with dark grey tin, plastering wall with sand-concrete mortar, restoration of wooden ornaments, lining of socle with basalt, arrangement of a new stairs with

basalt and wooden railings, restoration of glazed loggia, arrangement of new floor, ceiling for loggia and installation of new doors and windows, reconstruction of wooden extension. Balcony at the western façade will be restored and reinforced; damaged fragments will be replaced with new ones.

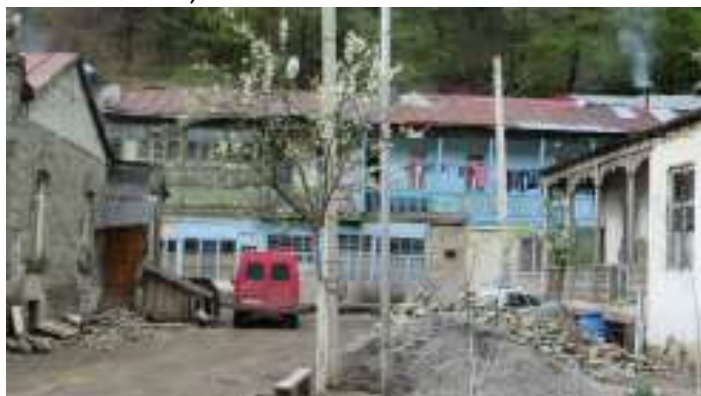
The two-storied building is built with natural stone. At the front façade, there is a wooden railing and a glazed loggia. Within the SP, the following works are planned: arrangement of new roof with dark grey tin, wooden baldachin above the entrance, plastering and painting walls, arrangement of stairs with basalt, restoration of wooden decorative ornaments, rehabilitation of the existing wooden stairs, windows and doors.

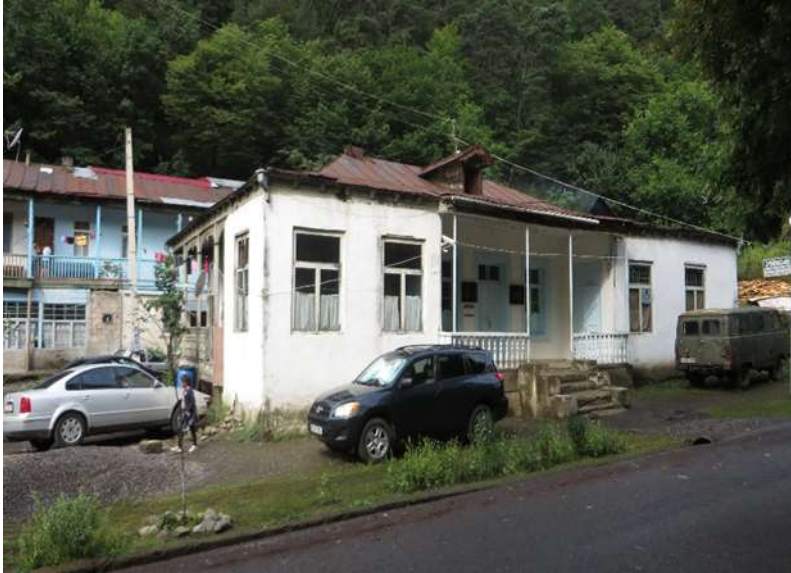
### **Building #104**

The one-storied building is a cultural heritage monument. Under the presented SP, the following works will be carried out: arrangement of new roof with dark grey tin, restoration of the existing gable window on the roof and its decorative elements, rehabilitation of the balconies, plastering and painting walls, arrangement of stairs with basalt, restoration of wooden decorative ornaments, installation of new windows and doors.

Excess earth will to be removed from northern façade. Damaged plastered layer present on all facades will be removed, plastered with sand and cement mortar.
