## **GEORGIA: GEORGIAN SUSTAINABLE URBAN TRANSPORT INVESTMENT PROGRAM, Tranche 2**

## Modernization of Tbilisi-Rustavi Section of the Tbilisi- Red Bridge (Azerbaijani Border) Road Project (Sections 1 and 3)

### **Environmental Monitoring Report**

**July, 2016**

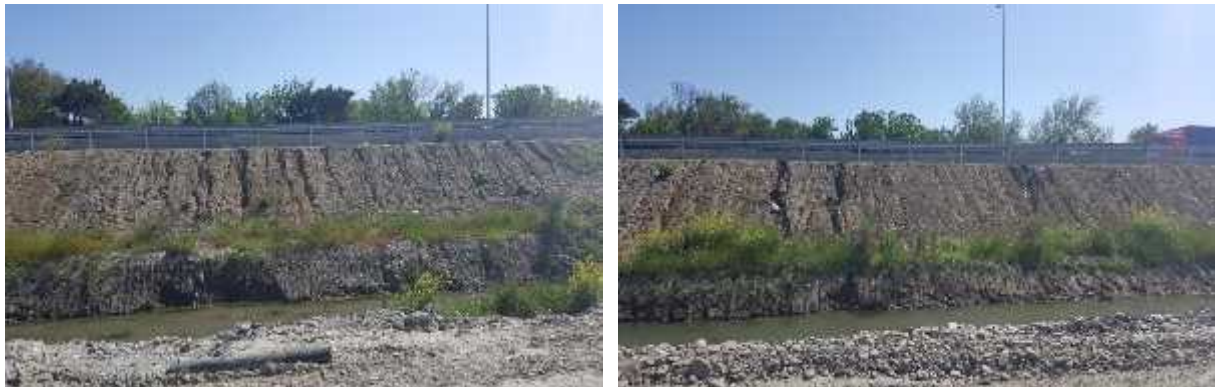
**Figures 1 and 2: Erosion of slopes of embankment**

**Existing situation:** Slopes of the Embankment at section 3 are covered by subsoil instead of topsoil. Erosion processes on slopes were activated.

**Proposed Corrective action:** The Contractor shall fill all cracks and ensure growing of grass on the slopes of section 3. In the case, if in May 2017 cracks on the slopes will be visible and grass will not grow, the Employer will deduct adequately calculated amount from the Contractor's guaranty and appoint another contractor to restore the slopes of embankment.

- The Contractor shall fill all cracks and ensure growing of grass on the slopes of section 3.
- The Contractor shall plant new trees instead of withered ones, in autumn 2016. Important, that guaranty period (1 year) should be started in autumn 2016. The Employer should monitor planting activities and check condition of trees in May and in autumn, 2017.

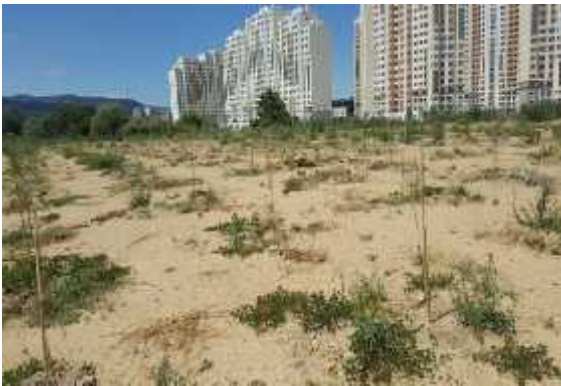
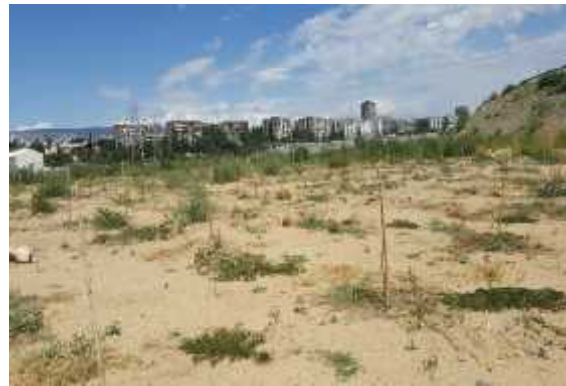
**Figures 3 and 4: 30% of trees, planted on PK20 of section 1 were withered**

42. **Non-Compliance 2:** At section 1 on PK20 195+823 = 1,018 trees were planted in total, from which approximately 300 trees were withered, which is 30% of planted trees on mentioned location. It should be noted that at this place withering rate was highest. In other places withering was quite low. In general only 13-14% of all planted trees (5,474) were withered.

**Proposed Corrective action:** The Contractor shall plant new trees instead of withered ones in autumn 2016. Important, that guaranty period (1 year) should be started from autumn 2016. The Employer will monitor planting activities and check condition of trees in May and in autumn 2017.
