Biannual Environmental Monitoring Report

Reporting period: July-December, 2015

GEORGIA: GEORGIAN SUSTAINABLE URBAN TRANSPORT INVESTMENT PROGRAM, Tranche 1

Tbilisi Metro Extension Project

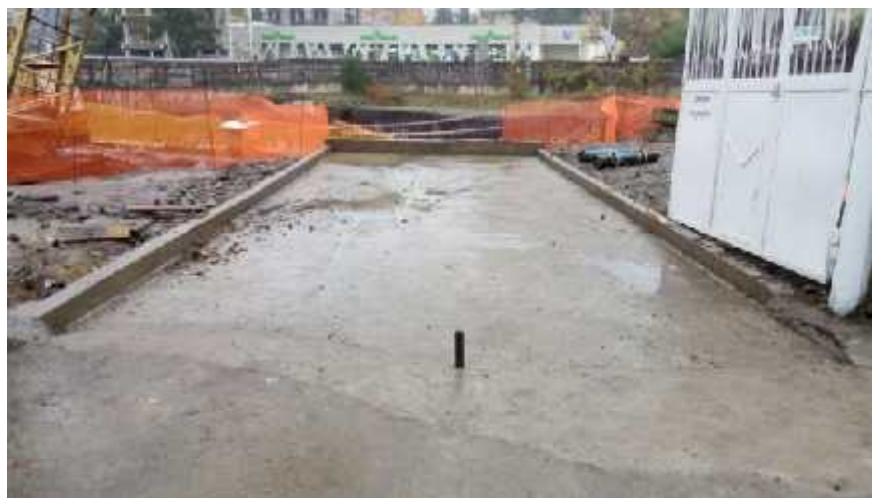
Picture 1: Vehicle washing area

Contractor made platform with basin for vehicle wheel washing at the entrance of upper station from where the construction material and waste has to be disposed (see picture 1 below).

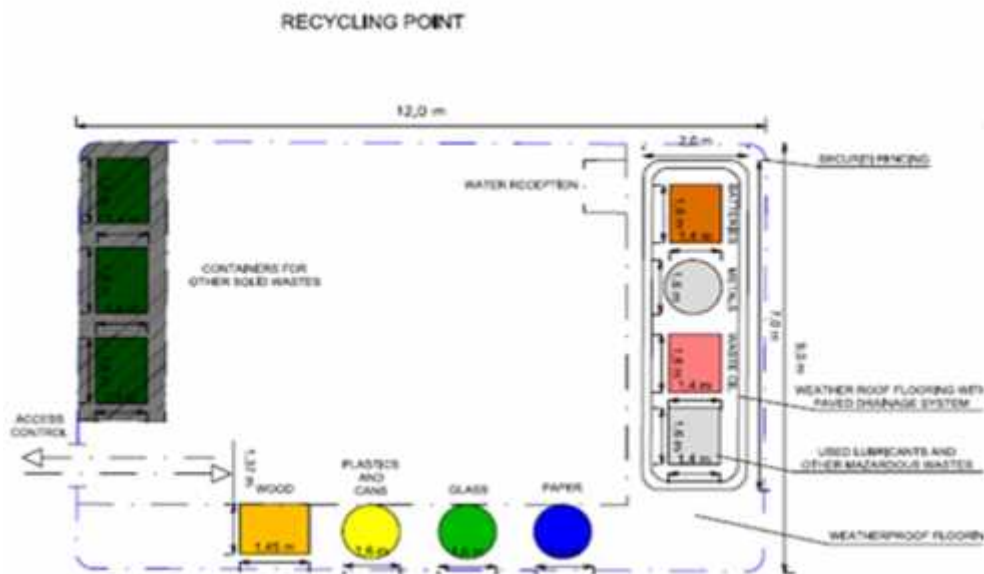
According the information provided by the contractor and the data compiled in situ, there is just a separation in waste materials, that consist on construction waste and hazardous materials, nevertheless, according to EMP/SSEMP of the environmental Project, it is recommended to make a more careful separation, as it is represented in the drawing below:

Until now, the separation of wastes consists of hazardous and non-hazardous materials. It is recommended to make a more selective separation among the non-hazardous materials.

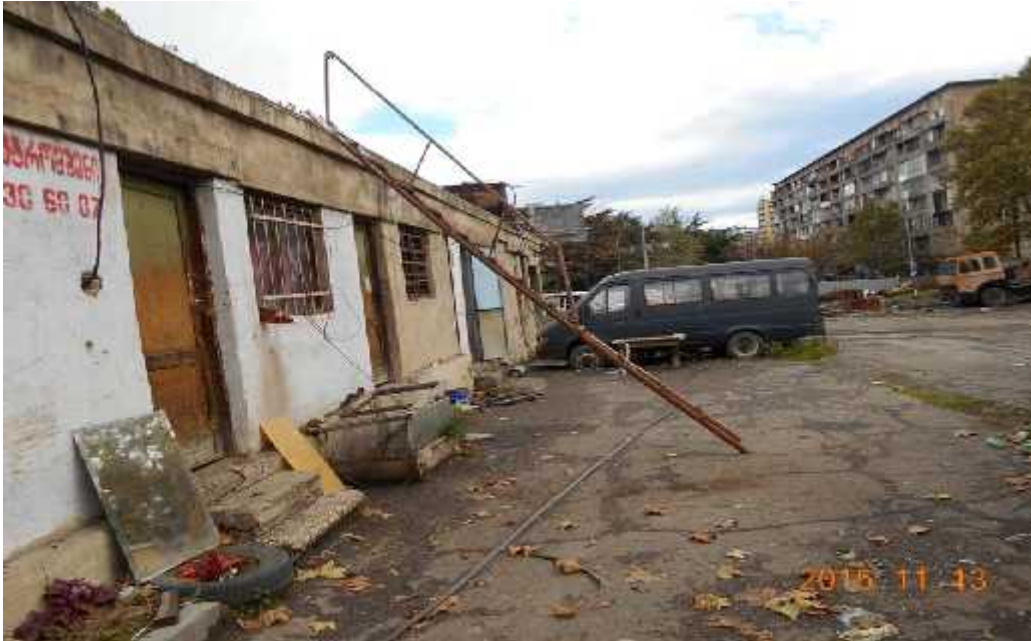
It is highlighting that the area close to the offices of the contractor and consultant presents a lot of wastes that include abandoned cars and old pipes. It is required to remove it.

Photograph 1. Area close to the offices that must be cleaned. Details of abandoned vehicles

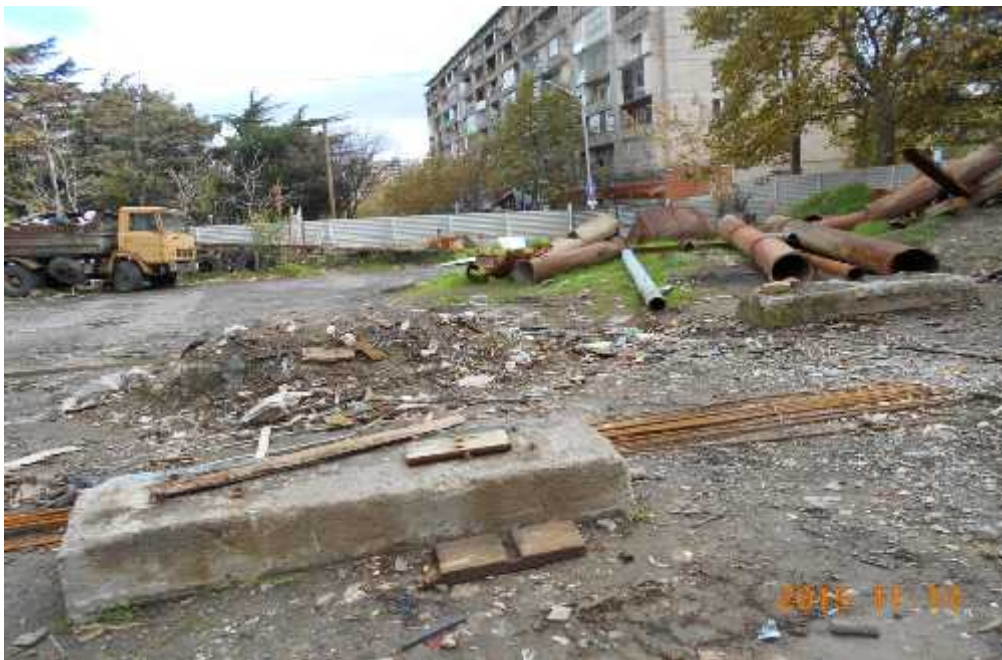
Photograph 2. Area close to the offices that must be cleaned, details of old pipes

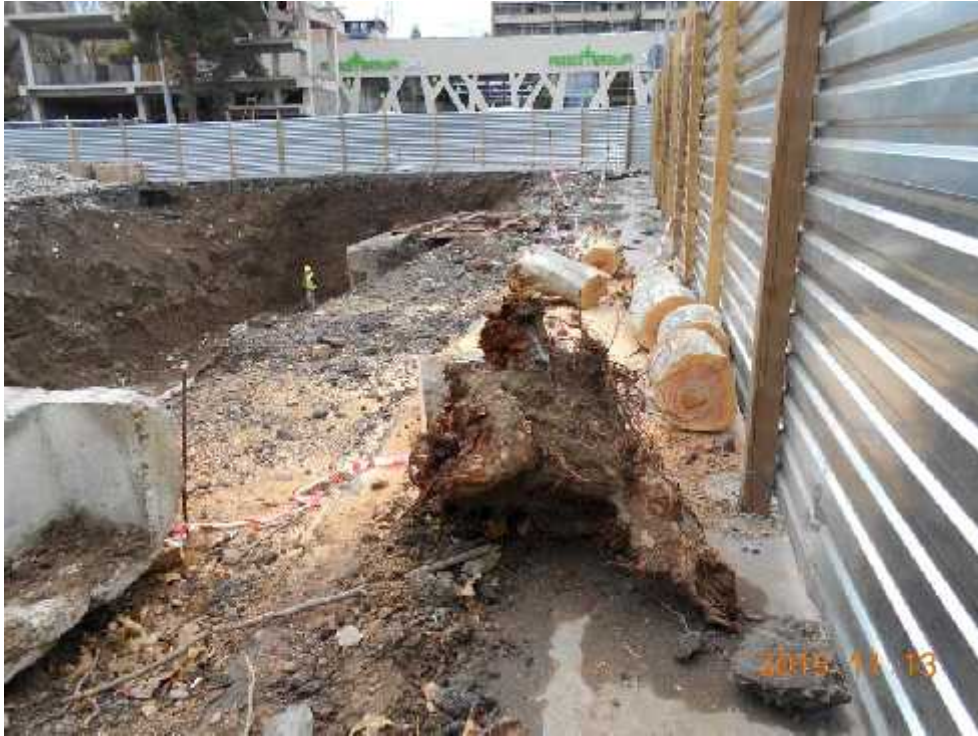
On 07.10.2015 contractor cut branches of three units of trees nearby flat N 98 located in Vazha Pshavela Ave. based on City hall permission.

Photograph 3. Cut tree (the permits to do it were processed)

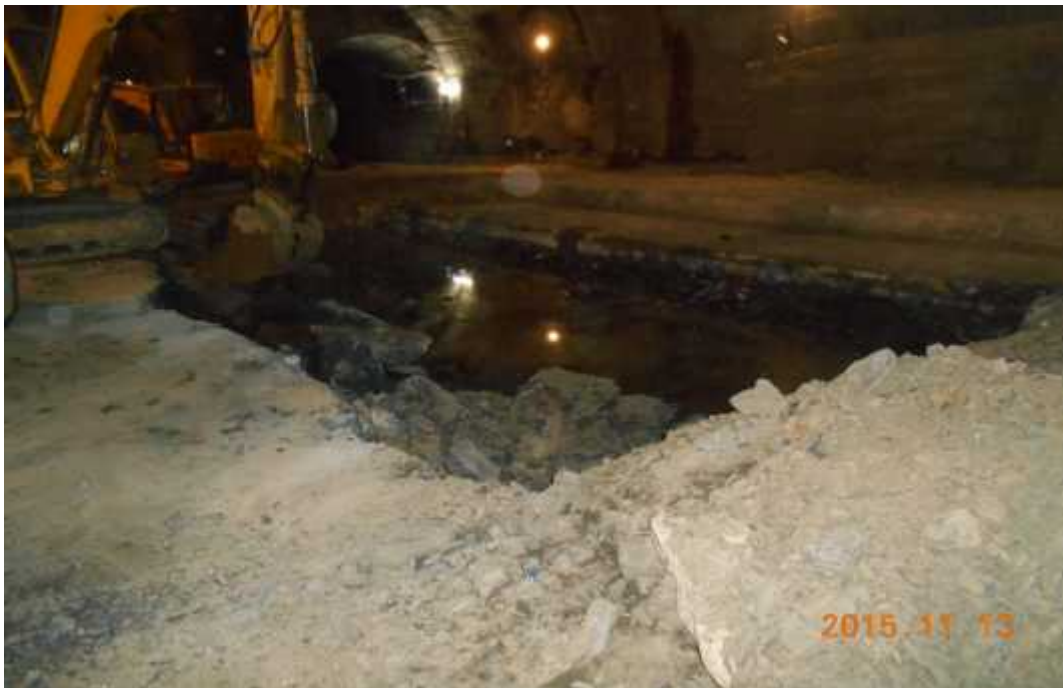
Photograph 4: Area inside the tunnels with zones of water accumulation

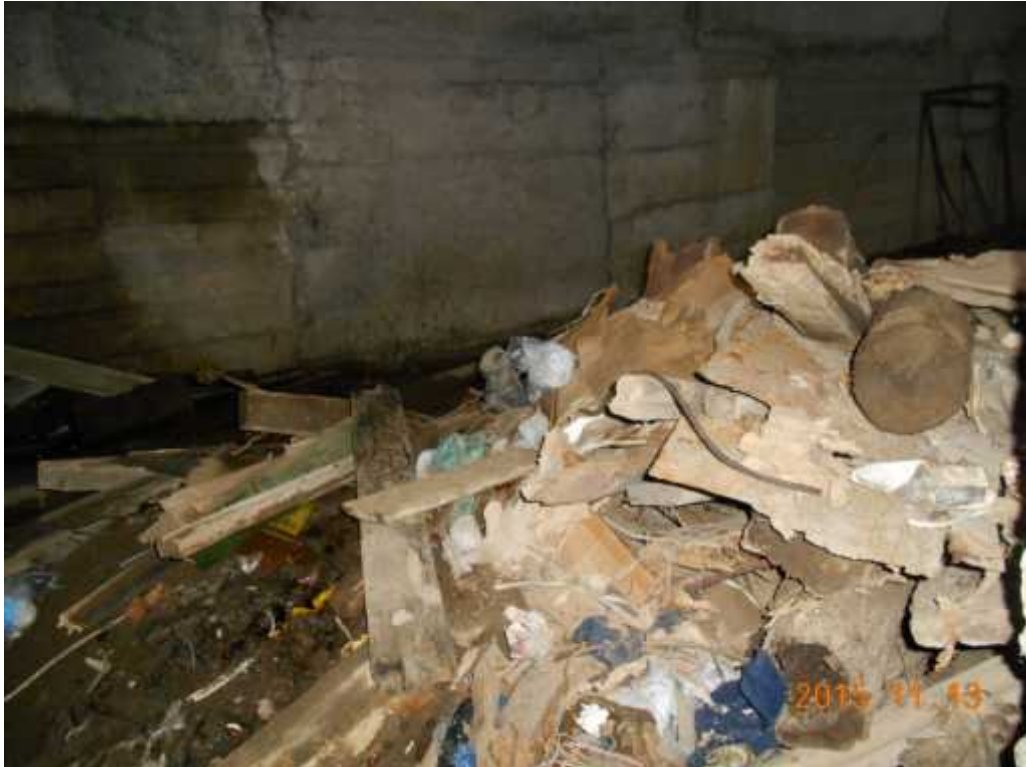
Photograph 5: area behind one of the air duct. There is accumulation of wastes that must be removed.

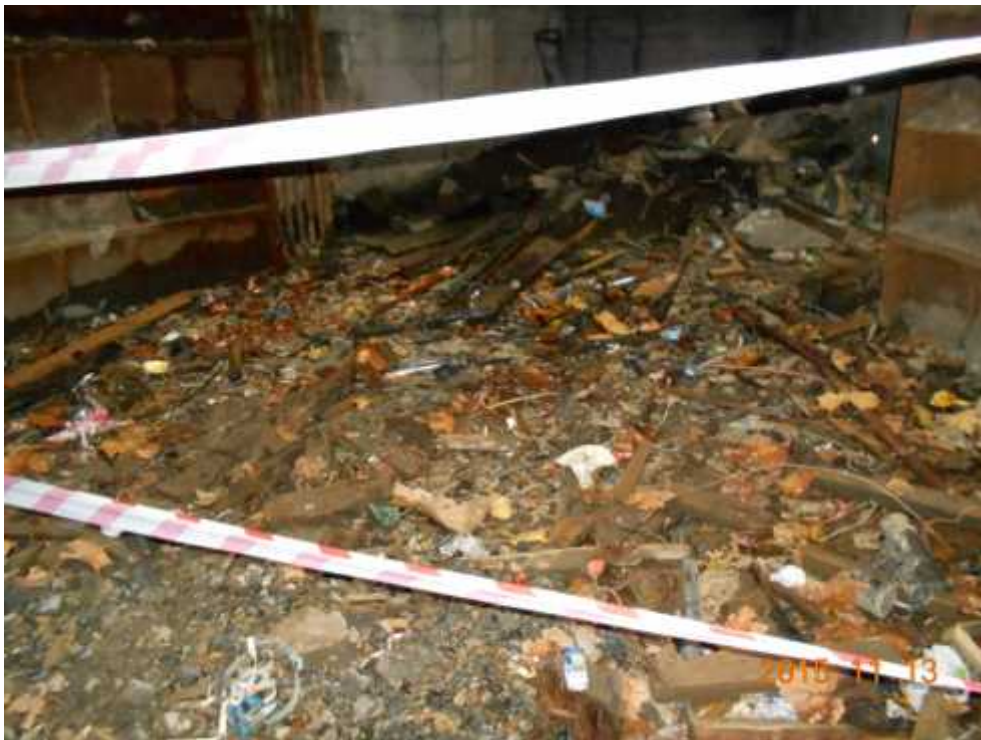
Photograph 6: Details of the area mentioned in the photograph 5.

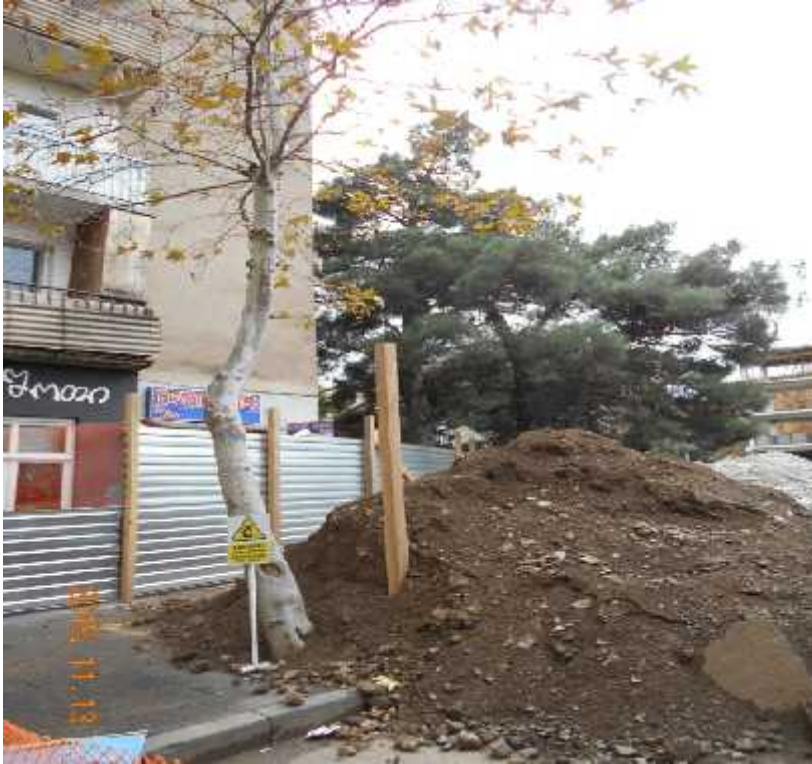
Photograph 7. Three that is going to be affected by the works and shall be cut later on

Regarding the affected trees, it is recommended to mark with a spray the trees that are going to be cut, so that the rest of the trees could be properly protected. It is recommended to use physical protection method as are described in the figure below.

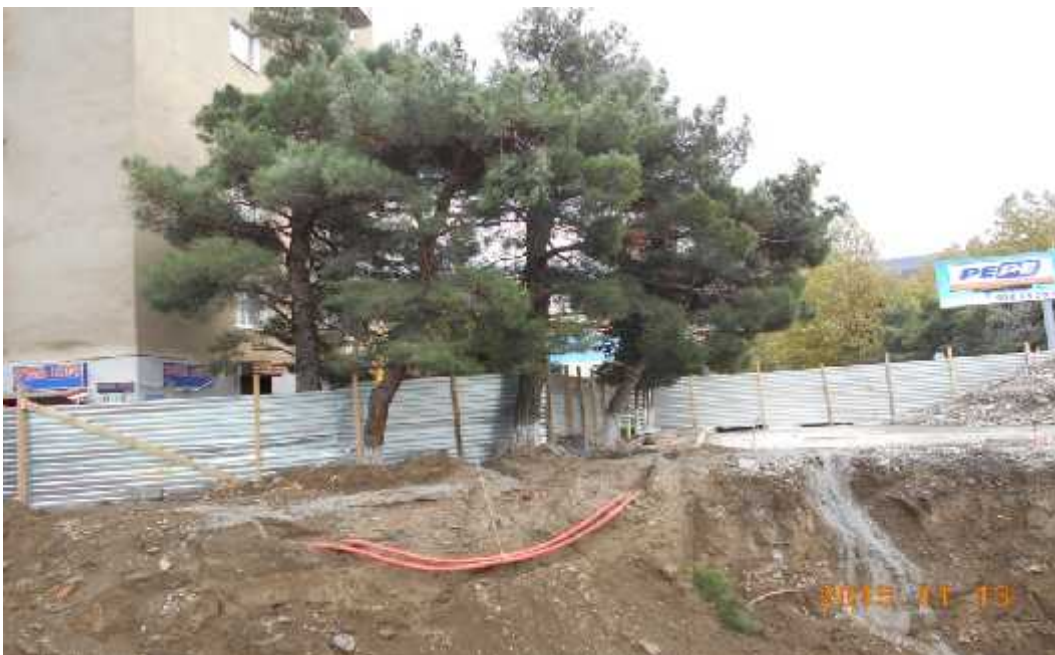
Photograph 8: thress that must be properly protected for not being affected by the execution of the works

- Regarding the affected trees, it is recommended to mark with a spray the trees that are going to be cut, so that the rest of the trees could be properly protected.
- It has been detected a smell to Sulphur in the tunnel that should be located. Waters close to this area where this smell has been detected should be analyzed.
- The point in which future samples of water to analyze, or noise data collection or other type of analysis should be located in a drawing.

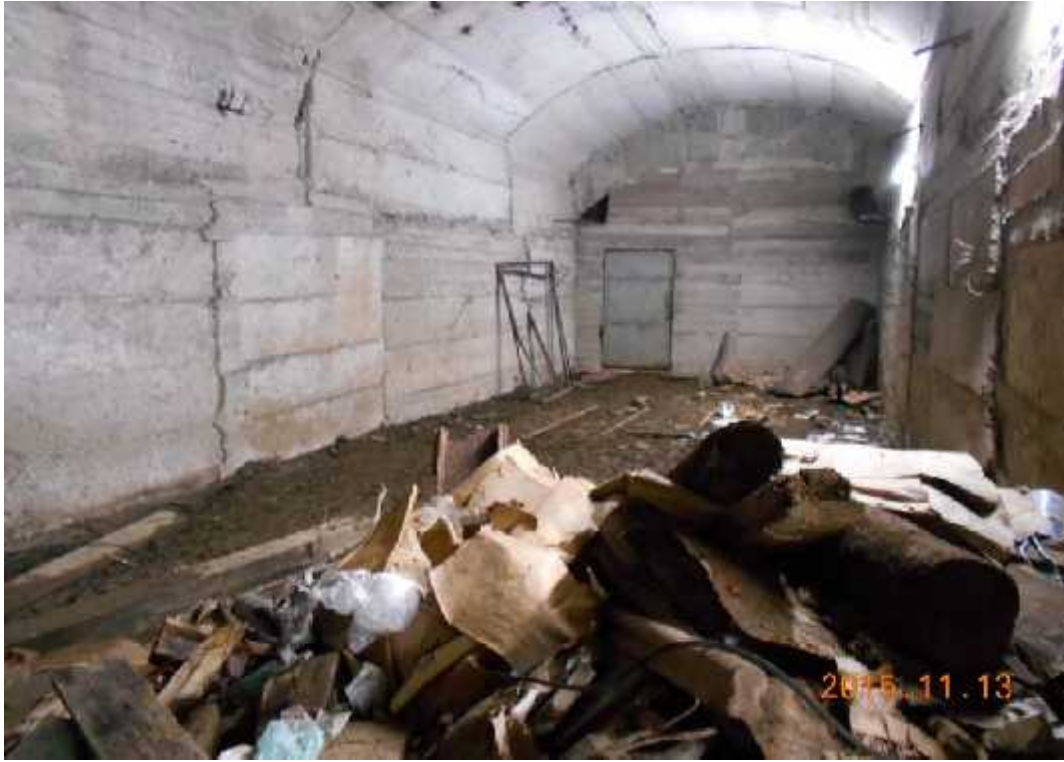
Photograph 9: Area inside the tunnels with rubbish accumulation that must be removed
