Biannual Environmental Monitoring Report

Reporting period: **July-December, 2017**

GEORGIA: SUSTAINABLE URBAN TRANSPORT INVESTMENT PROGRAM, Tranche 3

Tbilisi-Rustavi urban link (Section 2) CW Project – overview

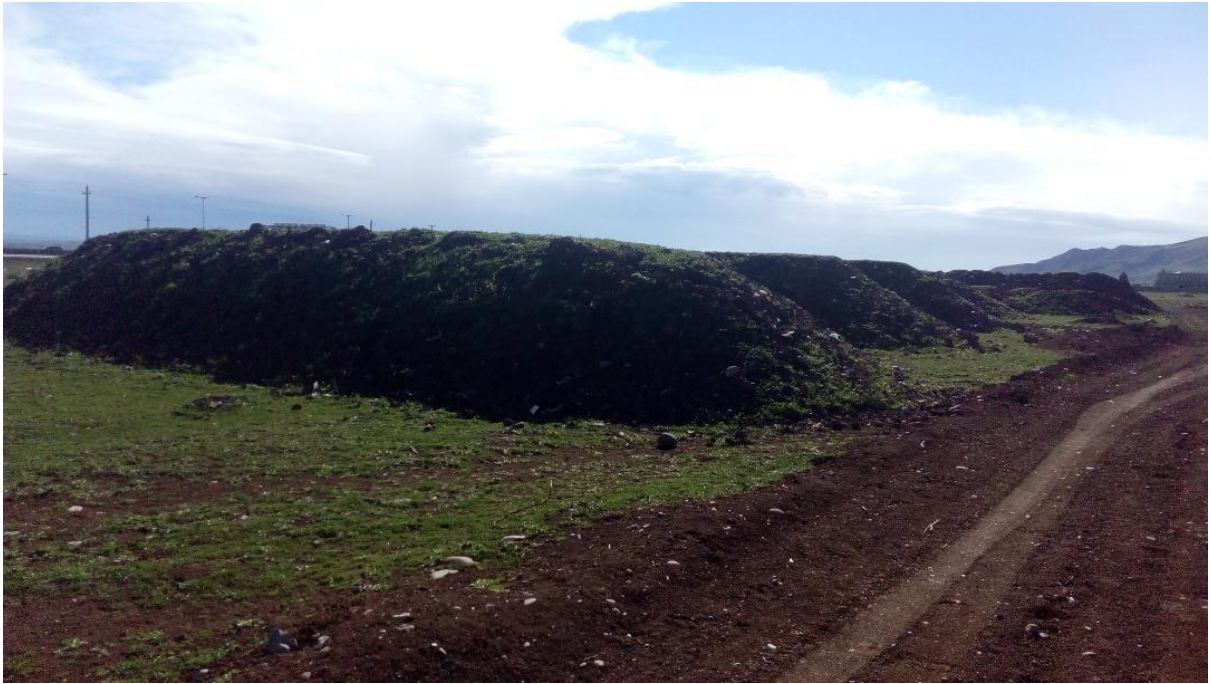
75. Contractor minimizes usage of productive agricultural land and after completion of civil works will convert them to their original state. Embankments are monitored during construction for signs of erosion; grass has already been grown on the top soil stockpiles and they are protected from erosion. The storage of topsoil in stockpiles is conducted with relevant procedures and standards: no more than 2m high with side slopes at a maximum angle of 45°. The topsoil is segregated from subsoil stockpiles. Special, separated storage area is allocated for the top soil storing to prevent the stockpiles being compacted by vehicle movements or contaminated by other materials. The area is protected from potential flooding. (Photos are provided at Annex 3). Topsoil stockpiles are monitored and in case of any adverse conditions be identified corrective actions will be taken.

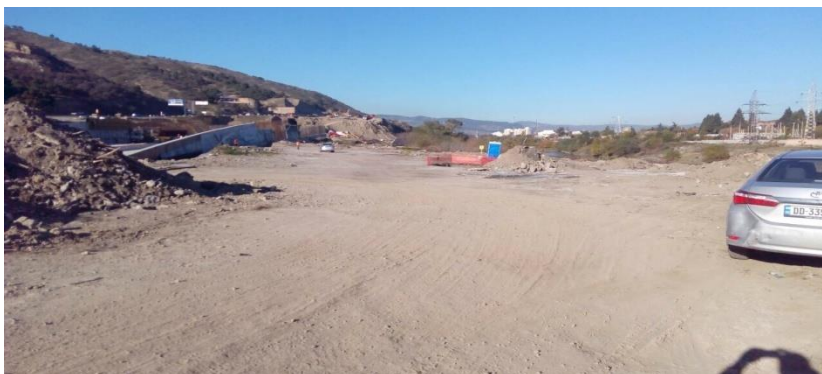
- **Construction Site:**
 - Tunnel excavation section: It was observed that municipal waste thrown directly on the ground along the fencing as well as used tires.

- KP. 4. 400 – Retaining wall construction section: a) Construction vehicles produced dust in dry weather. Spraying of water during the dry weather is necessary; b) Concrete has washed off the section near the retaining wall construction area, request made for installation of concrete washout pit; c) small oil spill was also observed at the construction area.

- Municipal waste has been collected and disposed on municipal landfill;

- The Contractor is spraying water on site during dry weather;
- Washout pit was excavated on PK4.800
