Urban regeneration of historical streets in Dusheti

Environmental Review

Third Regional Development Project

January, 2018

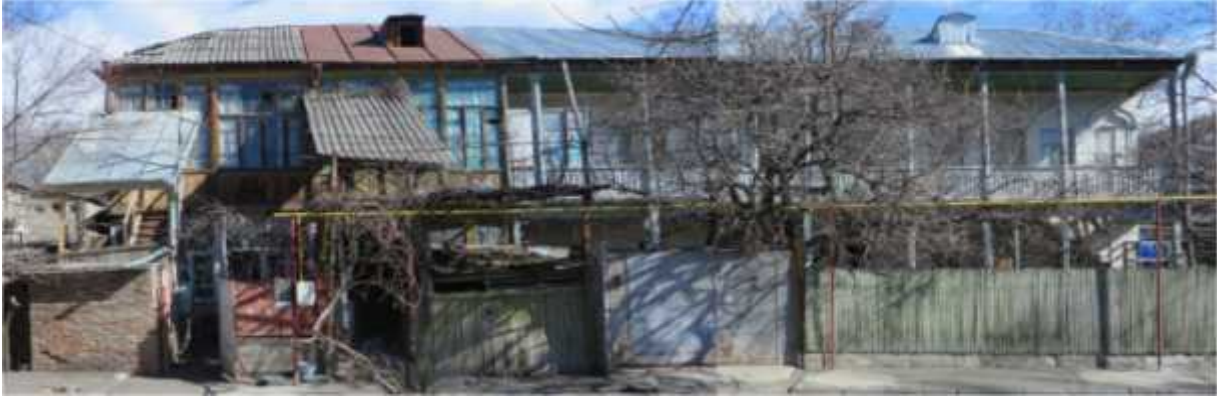
The SP envisages rehabilitation of the building façade of the house #1 and #3 on Erekle II Street and replacement of its roofing.

In particular, the design includes repairing and restoration of the façade plastering, replacement of the doors and windows, replacement of the wooden balconies and glass gallery with the new ones along the entire perimeter of the façade, arrangement of wooden staircases accessing to the balconies. Also, dismantling of the existing brick and wooden fences around the courtyard and the metal gate, and arrangement of new fence with mixed brick and stone masonry. Wooden planks and tin cover of the roof will be replaced by the gray color tin sheets.

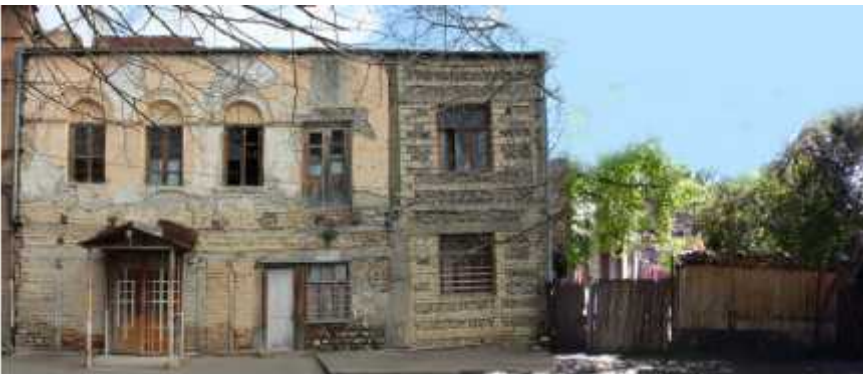
The SP includes rehabilitation of the house facade and roof replacement. In particular, cleaning of the

façade from existing plastering, replacement of doors and windows, rebuilt a wooden balcony (similar to balcony of the house on Erekle II Street # 9) from Erekle II street side. There is also envisaged dismantling of the existing wooden fence and metal

gate and arrangement of new fence with mixed brick and stone masonry and a metal gate, replacement of wooden planks and tin cover of the roof by the gray color tin sheets.

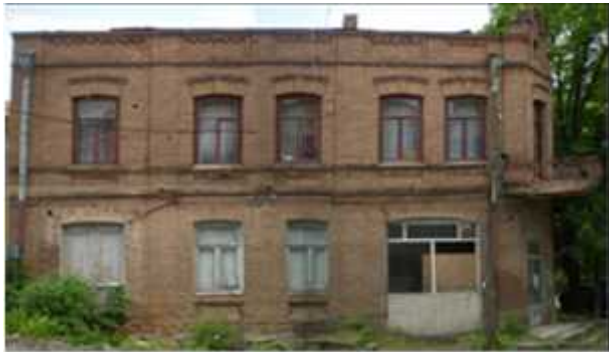
The project includes rehabilitation of the building facade, replacement of roof, restoration of the outside

decorative wooden balconies and replacement of doors and windows with new ones. Rehabilitation of facades includes cleaning of brick-work using sand jet blower, restoration of damaged areas, cleaning of forged balcony from existing paint and its painting, restoration of the wooden decorative elements from the yard, and replacing of the missing part with the new one, dismantling of the ugly staircase going to the second and arrangement of new wooden one using the existing wooden decorative elements. The wooden planks and tin cover will be replaced with new one.

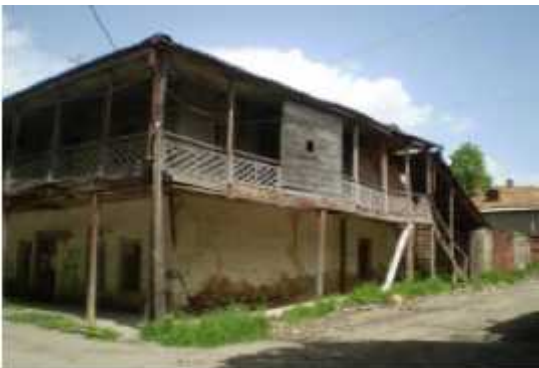
#9 and #11 Erekle II Street (Cultural Heritage Monument)

The Houses located on Erekle street #9 and # 11 actually are one building.

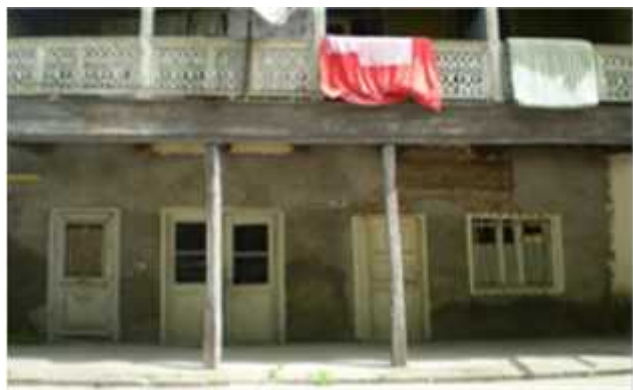
House located on #11 Erekle II Street is a two-storey building with wooden balconies along the entire facades of the building. The total area of the façade is 126 m², the total area of the roof is 225 m². The project considers removal of the existing façade plating and its re-plastering, repairing-resoration of the plastered cornices, replacement of the doors and windows, and wooden balcony on the entire length of the facade, arrangement of the stained glass windows

and repairing of the balcony from the yard side (replacing damaged elements) on the first floor, replacement of wooden planks and tin cover of the roof (tile and dark tin sheets).

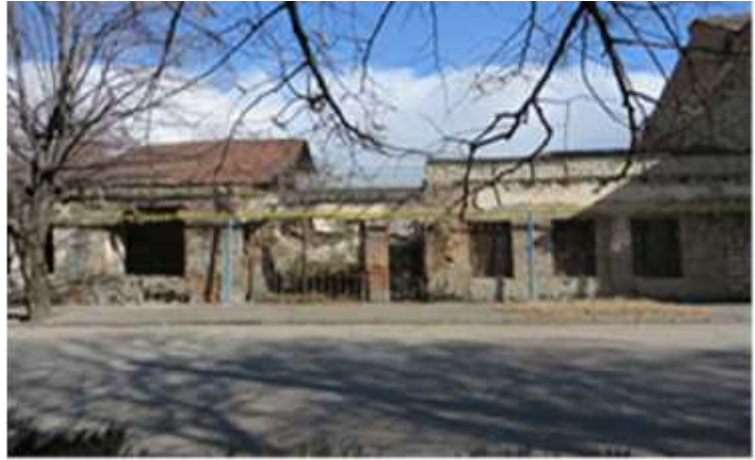
The house is a one-storey brick building with a basement. The inner courtyard divides the building into two blocks. The right block is a residential home. The SP envisages rehabilitation of façade and replacement of roof cover. The façade rehabilitation works includes clearing of brick arches from fragments built with block and silicate brick, as well as changing the silicate brick parapet with the Georgian brick parapet. There will be arranged wooden stained glass windows inside the brick arches. The left block of the building is practically demolished. The SP envisages: cleaning of the building and yard from garbage and shrubbery; Reinforcement of some parts of the walls and rebuilding of the others, arrangement of the reinforced concrete roofs between the floors and staircase entering down to the basement; Restoration of damaged arches and brick parapets; Arrangement of roof with wooden structures that will be cover with gray tin sheets, the roofing cover will be changed in the right block of the building as well; The metal gate will be replaced with new one; fortified and re-built walls will be plastered with sand-cement mortar (in the interior), in the restored brick arches the wooden wooden stained glass windows will be arranged.

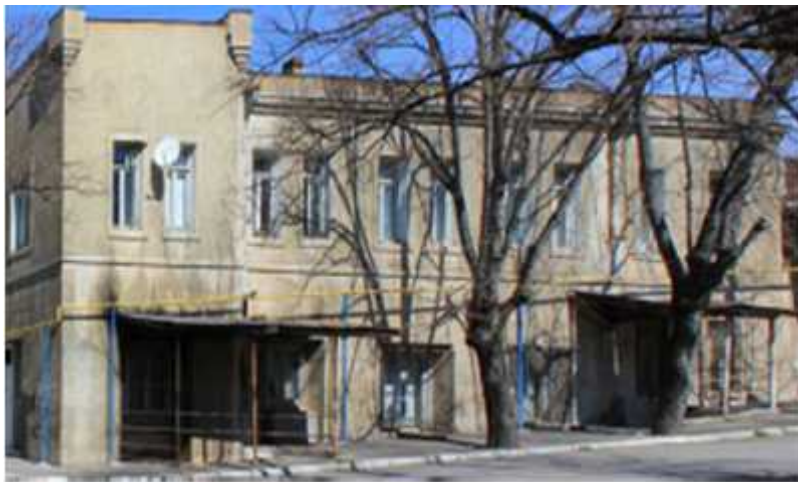
#17 Erekle II Street

The SP envisages replacement of the roof, refurbishment of the library (occupies 214.2 m² in the building) and Free Dining Hall of Dusheti Municipality for the People Deprived of Care (occupies 144.5 m² in the building), replacement of doors and windows with the new ones.

Rehabilitation of the facades includes its cleaning with sand jet blower, restoration of the damaged parts, re-building the balconies with metal railing (presumably these balconies existed in the past). The library book stack needs repairing of walls, ceiling and floor. Damaged parquet floor will be replaced with high quality laminated floor, the

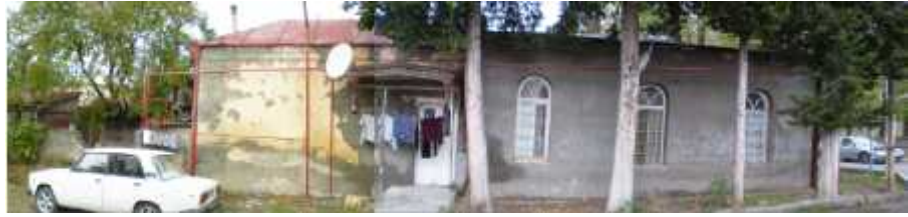
The SP envisages rehabilitation of the façade and the replacement of the roof, namely: cleaning the facade from the remained

plastering, restoration of plastered cornices, replacement doors and windows and canopies; dismantling the yard fence and metal gate and arrangement of new block fence and installation of metal gate, replacing wooden planking and tin cover of the roof.

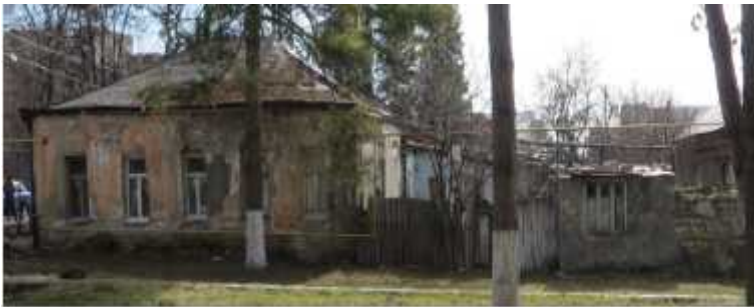
#32 Kostava Street (Cultural Heritage Monument²)

The SP envisages the rehabilitation of the building façade and the replacement of the roof, namely: cleaning the facade from the remained plastering, restoration of plastered cornices, replacing doors and windows and canopies, dismantling of fence of the yard and the metal gate and arrangement of new block fence and

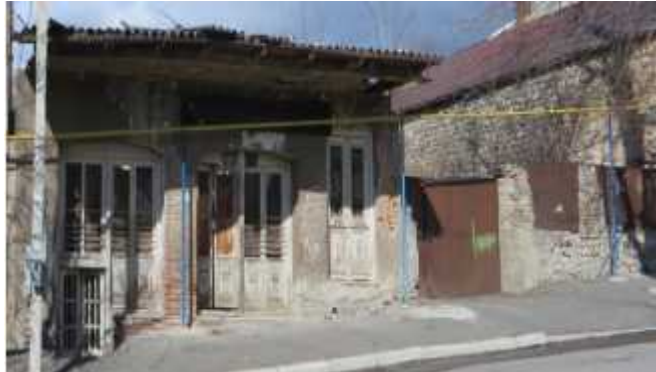
The house is a one-storey brick building with a basement that is damaged currently. The SP implies the following works: Restoration of the building and cleaning of yard from the rubbish and shrubbery. Some part of retining wall will be strengthened and other part rebuilt floors, between the floores the reinforced concrete slabs will be arranged, staircase leading down to the basement will be arranged, existing plaster from façade and inner walls will removed. A new roof with woodens structures will be arranged that will be covered with gray tin sheets, metal gate and fence will be replaced with new one, some part of the doors and windows will be restored and other replacemed with new ones, strengthened and rebuilt walles and filled walls of will be plastered with sand-cement mortar.

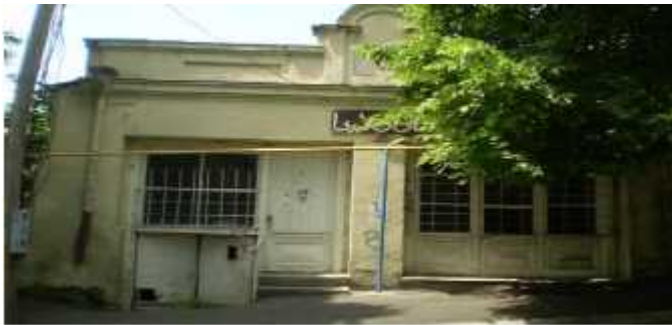
#16, #18 and #20 St. Ninos Street

The SP envisages restoration of facades and replacement of the roofs of the houses #16, #18 and #20 St. Nino Street.

At present, the **house # 16 (Cultural Heritage Monument⁴)**, is a one-storey with a basement, and requires repair and restoration of the façade of and plastered cornices, replacement doors and windows, and restoration of staircase passing to the facase and leading down to the basement (basalt slabs).

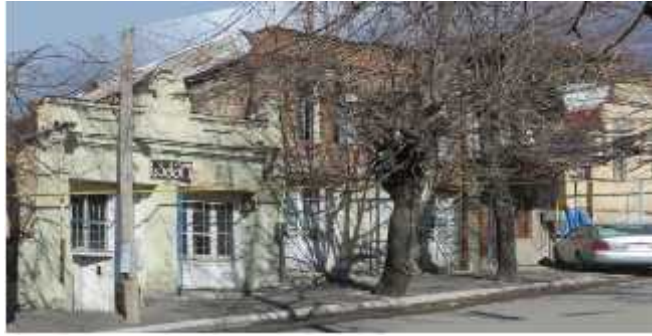
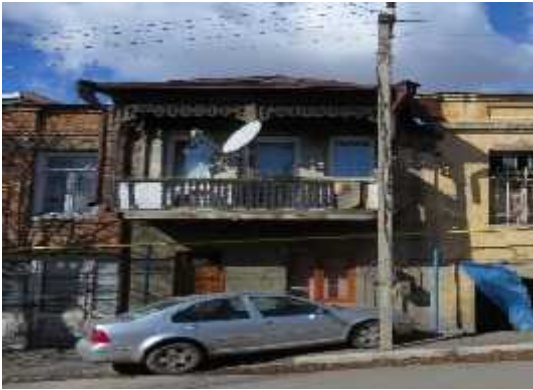
The house # 18 represents the two-storey brick building, the first floor of which is poorly plastered and on the second floor is provided an ugly masonry. The project envisages removal of façade bad-quality plaster, plastering of entire façade with sand-cement mortar, replacement of doors and windows and restoration of stair steps.

House # 20 (Cultural Heritage Monument⁵) - Two-storey brick building with wooden balconies. The entire façade will be cleaned from poor quality and damaged plaster, the doors and windows will be replaced, the open balcony will be restored (the most part of the balcony will be replaced with new ones), the facade will be plastered with sand-cement mortar.

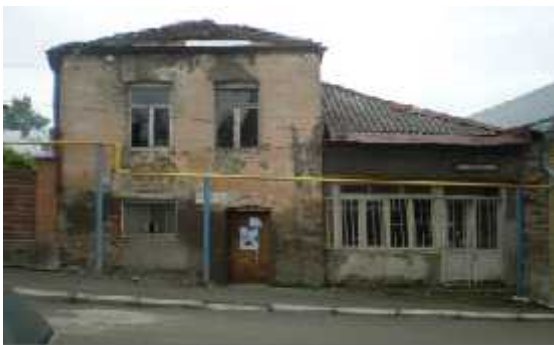
19 St. Ninos Street

The SP includes rehabilitation of building façade and replacement of the roof. As of today, one part of a House # 13 is a two-story and the other part – one-storey. The SP provides works for removal of bad-quality plaster and re-plastering of entire façade of the building with sand-cement mortar. Replacement of doors and windows and restoration of stair steps. The roof planking and tin cover will be replaced with gray color tin sheets.

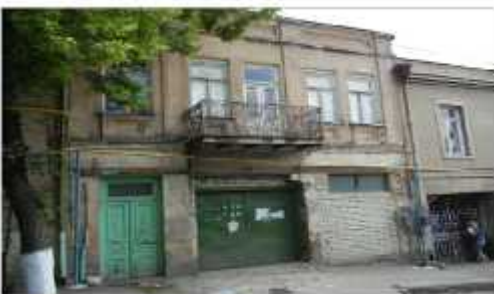
39, # 41, # 43, # 45 and # 51 Shota Rustaveli Street

House # 39 (Cultural Heritage Monument⁶) The SP considers removal of existing plastering, re-plastering and painting. Replacement of roof rainwater drainage pipes on the roof; Restoration of doors and windows on the second floor and the main entrance door on the first floor. Replacement of large door and window on the first floor, finishing of the stair with basalt tiles at the main entrance of the building, cleaning and painting of the balcony railing.

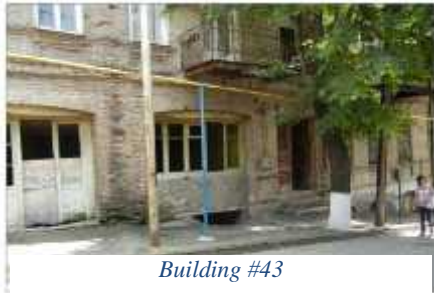
Building #43

House # 43-41 (Cultural Heritage Monument⁷) is a two-storey brick building with a basement. The SP envisages rehabilitation of the façade, replacement of doors and windows in the basement and on the first floor of the building, doors and windows on the second floor will be restored, new stained glass windows will be installed and main entrance door restored. The entrance stairs will be finished with

basalt slabs. The balcony railing of the house # 43 will be cleaned and painted. On the balcony of # 41 balcony railing similar to house # 43 balcony railing will be installed and painted.

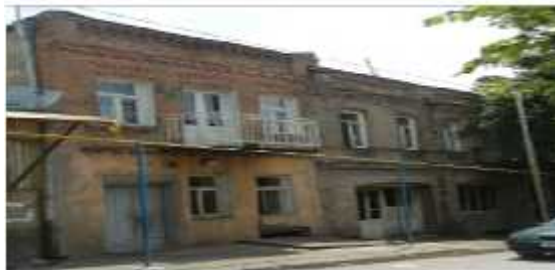
House # 45 is a two-storey brick building with basement. The project envisages rehabilitation of façade, removal of the old plastering and cleaning with special device. Replacement of ceiling planckes, tin cover and restoration of the facade; Replacing doors and windows on the both floors and a basement door. Cleaning and painting of a balcony railing.

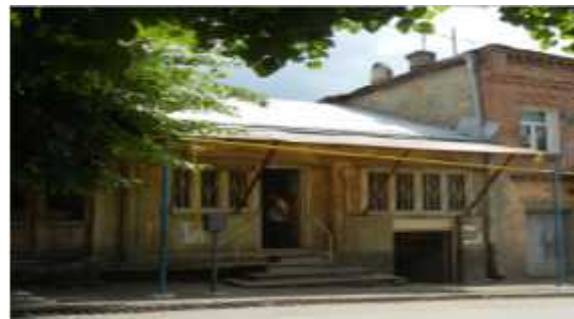
House # 51 (Cultural Heritage Monument⁸) is a one-storey building with a basement which is built with brick. The SP includes rehabilitation of the façades, rearrange of shad of the building, replacing of stained-glass windows, doors, windows and the basement door, also finishing the stair at the entrance with basalt slabs.

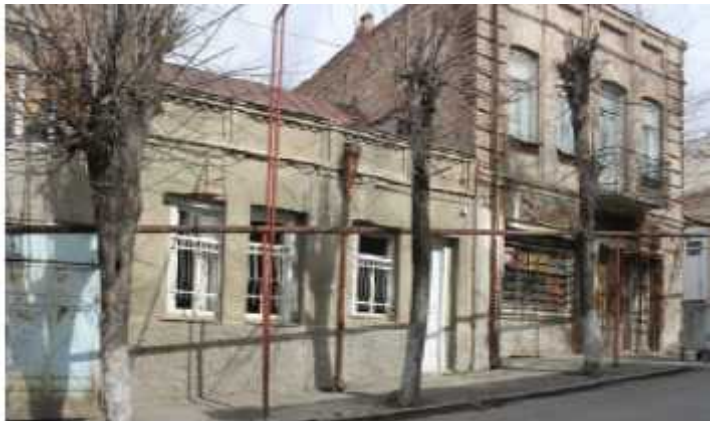
68 Shota Rustaveli Street

House is a one-storey building. The SP envisages rehabilitation of the building entire façade from Rustaveli Street. The following works will be implemented within the SP: dismantling of existing doors, windows and grilles; Removal of old tin coverer from the roof and water drain pipes; demolition of damaged wooden structures; Cleaning the façade from old plastering using sand-Jet machine. The reconstruction works include: restoration

of damaged wooden structures of the roof, arrangement of roof cover and water drain system; Restoration of the damaged façade revealed after old plaster removal; Installation of wooden doors and windows with metal grilles; inside the new door a simple profile staircase with basalt slabs will be arranged. Repairing and restoration parts of interior (engineering elements) damaged during the demolition works.

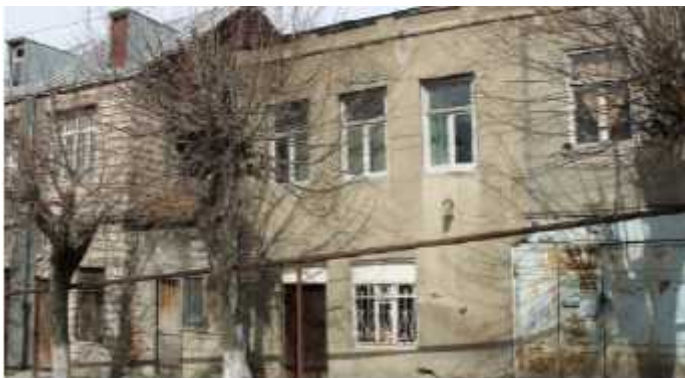
#70 Shota Rustaveli Street

The SP considers complete rehabilitation of the building façade from the side of Rustaveli Street. The reconstruction will not result in change the existing area of the building. Rehabilitation works include: dismantling the existing doors, windows and metal gate; removing the rebuilt parts of doors' and windows' openings on the first floor; removing the old tin cover of the roof and the water drain pipes; dismantling the damaged wooden structures and plancking

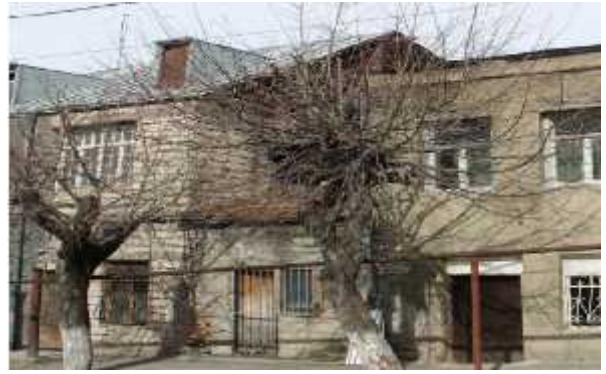
There are two buildings on this address. One of them is two-storey building with attic and has a one-storey building attached on it. The SP envisages full rehabilitation of the building façade from the side of Rustaveli street. The SP considers the dismantling of the existing doors, removal of the old tin cover from the roof and the water collecting pipes, removal of damaged wooden structures and planking of the roof, cleaning the façade from the old plastering with sand-jet blower, restoration of damaged wooden structures on the roof; Arrangement of roof cover and water drain system; Restoration of the damaged façade which was revealed after the removal of the old plastering; reconstruction of the attic incomplete wall and façade plastering with sand-cement mortar. Installation of wooden doors and windows; plastering the façade with sand-cement mortar and painting, setting a simple profile staircase with basalt slabs in front of the new door.

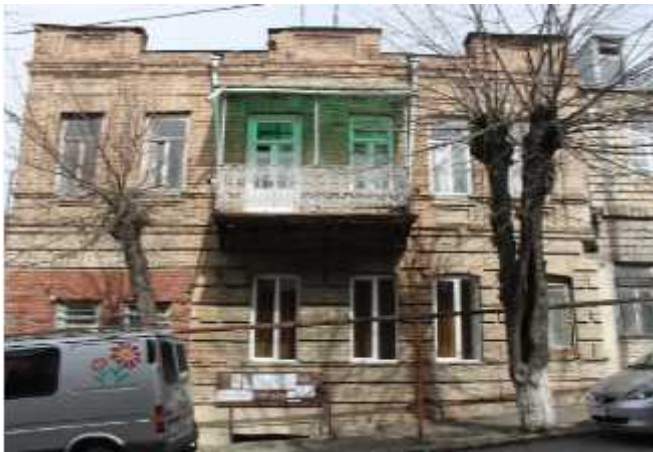
#74 Shota Rustaveli Street

The artistic value of the building is quite high and it plays an important role in creating of visual appearance of the street. According to the SP the rehabilitation of the building façade will be carried out from Rustaveli Street. The reconstruction works include: dismantling of existing doors, windows and grilles, metal structure of balcony overlap and wooden floor; Removal of old tin cover of the roof and water drain pipes; Removal of damaged wooden structures of the roof; Clearing the façade from old plater (basement) using sand-Jet machine, restoration of roof damaged wooden structures; Arrangement of new roof cover and water drain system; Restoration of the damaged elements of the façade identified after removal of the old plater; Installation of metal and wooden doors and windows, arranged a simple profile stair steps with basalt slabs in front of the entrance door. Installation of staircase and its railing in the basement; repairing and restoration of the interior parts (engineering elements) damaged during the dismantling works; replacement of balcony floor with a new cover; cleaning and painting balcony railings with metal paint.

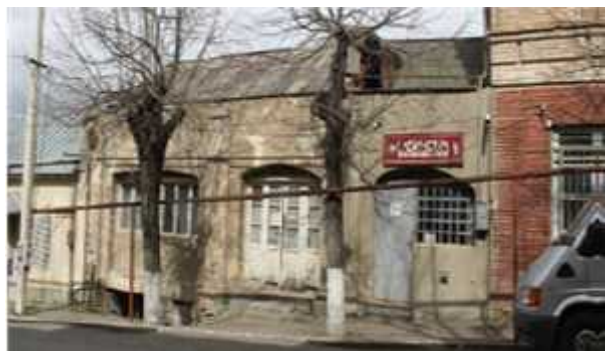
#76 Shota Rustaveli Street (Cultural Heritage Monument)

The SP considers demolition of façade damaged elements and dismantling of the existing tin cover and damaged wooden structures of the roof, doors and windows, clearing the staircase accessing to the basement, dismantling the railing, demolition of basement wall, cleaning the façade with sand-Jet blower; restoration of wall damaged fragments, Installation of doors and windows, facades' plating with sand-cement mortar, installation of wooden structures and the new roofing cover with gray tin sheets of the roof, and water drain pipes, painting the

doors and windows, arrangement of metal railing, basalt stair steps, staircase of leading down to the basement and its painting.

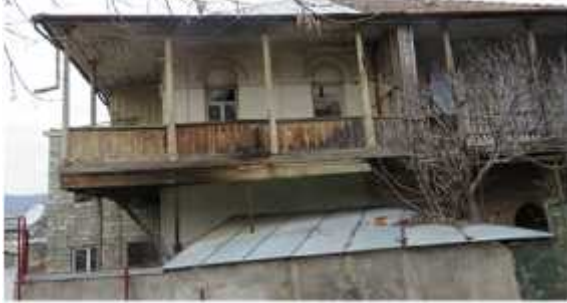
Aprellov House is located in the corner of Dadiani and Shamanauri streets. The SP includes the following works: Rehabilitation of the roof – entire replacement of the roof cover and planking, arrangement tile roofing on the building and tin cover on the balcony, fragmental strengthening of the roof wooden

structures, rehabilitation of the balcony and glass gallery – rearrangement of wooden columns and railings, fabrication and installation of new wooden rail post and and windows glass gallery. Complete replacement of ceiling planking and floors of the balcony. The replacement of doors and windows is not provided by the project. They will be cleaned, processed and painted with oil paints, plastering and

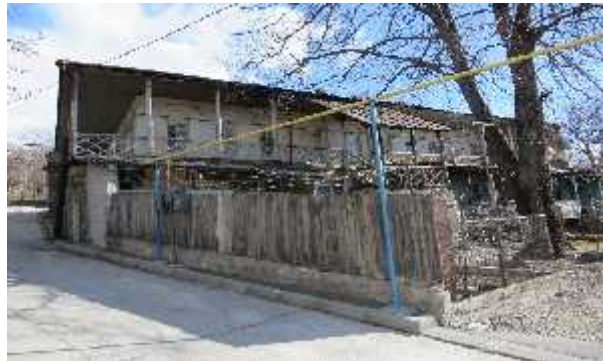
The building is located on Theater Street in which some time lived Ilia Chavchavadze, the famous Georgian writer and political figure. Currently, the building is amortized and needs necessary and urgent rehabilitation works. The SP envisages restoration of the exterior appearance, which includes rehabilitation of the facades, restoration of wooden units and decors of glass gallery and windows and doors of façade. All wooden items, decors, doors and windows will be processed and painted with oil paints.

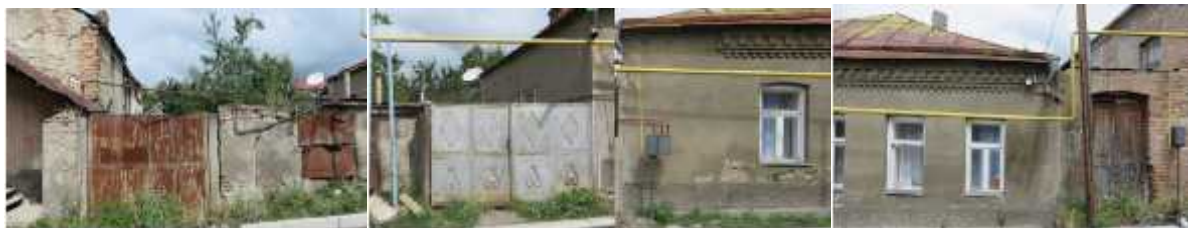
#6 and #8 Ilia Chavchavadze street (House #8 is a monument of cultural heritage)

Chavchavadze Street is located in perpendicular to Erekle II and Nazi Shamanauri streets. There will be replaced damaged roof of the house # 6 with dark gray tin and restored and painted the damaged parts of the façade within the project.

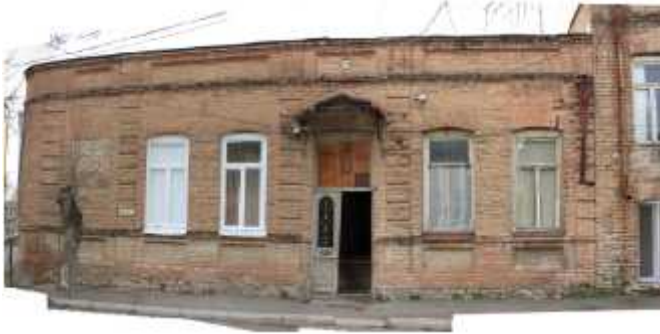
The SP envisages removal of the existing roof and arrangement of the dark tin sheets on the new wooden structure; Cleaning of the façade using sand-jet blower, replacing of the existing doors and windows with new wooden doors and windows, restoration of the entrance wooden door, in its original face;

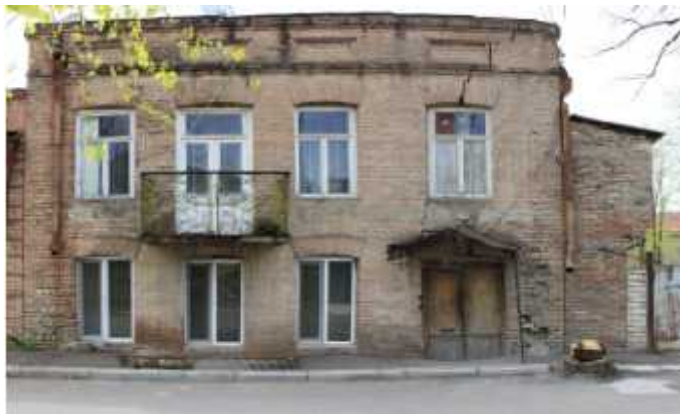
House is a two-story building, constructed with Old Russian brick and covered with ordinary black tin. The project envisages replacement of existing roof and arrangement of dark tin roofing. Replacement of wooden doors and windows, restoration of the wooden entrance door in its original form. The later rebuilt part will be rearranged with new metal structure, which will strengthen the cracked wall, the exterior damaged parts of the brick wall from the

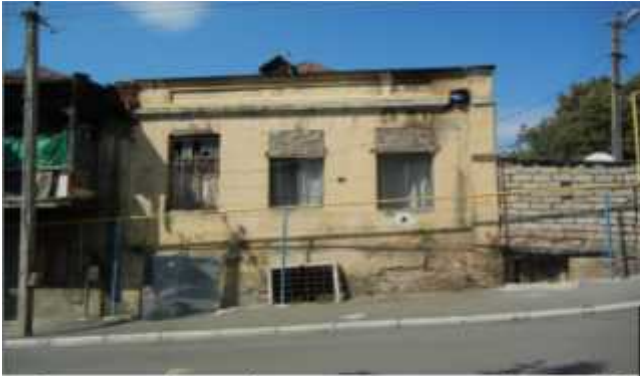
The one-storey brick building, which is later plastered, is located on Shamanauri street and its one façade goes out to the St. Nino Street. It is roofed with painted tin cover. The building has a basement and a small yard that is bordered by a fence.

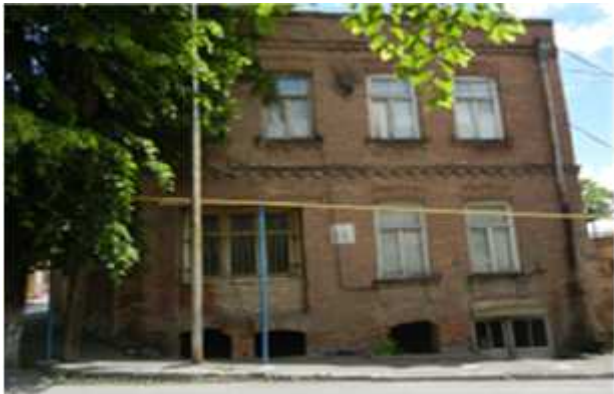
large basement in the building which has entrance from Rustaveli Street. The project includes removing of the existing roof cover and arranging a dark tin layer on a new wooden construction of the ceiling rafter. Restoration of demolished parts of the building such as: brick arche and doors at entrance of the yard, entrance door from

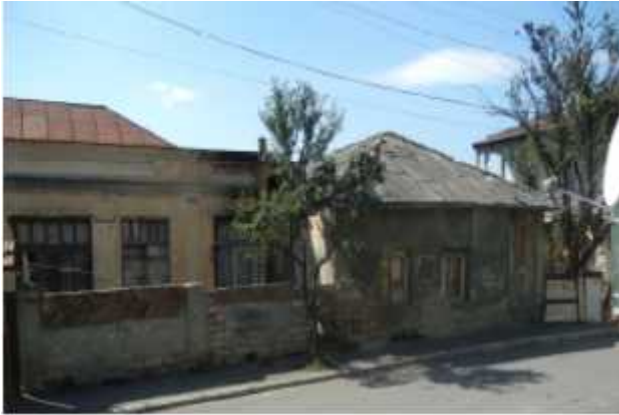
sheets. The building is damaged and requires serious constructive works. The SP envisages demolition of the existing roof cover and wooden structures, strengthening of the brick walls with reinforced concrete belts and arranging new roof structures, wood planking and roof cover, balcony with new constructions will be arranged as well, including: reinforced concrete roofing, wooden beams, columns, floor, ceiling and walls of the balcony. Part of the walls will be built with usual red bricks. The new wooden doors and windows will be installed, a brickwork fence will be arranged

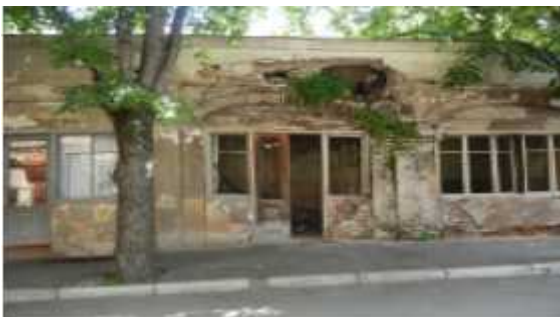
#57 Nazi Shamanauri Street (Cultural Heritage Monument¹⁴)

The house is a one-storey brick building, with backyard. In the left corner of the bulding from the Shamanauri street is located a store, after it is a living area, and in the rest area of the bulding floors and ceiling is demolished. Building was reconstructed several times and plastered.

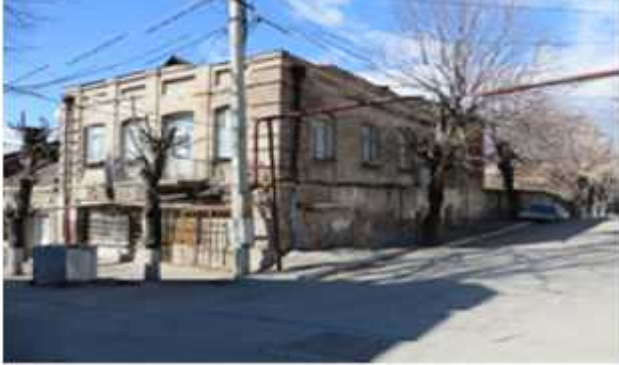
The two-storey building is built of stone and brick mixed masonry, and which later have been plastered. The second floor is built with brick. The rehabilitation works include removal of the existing roof and arrangement of the dark tin layer on the new wooden structure of ceiling rafter. Removal of cement plastering on the first floor and restoration of the old masonry, cleaning and restoration of the brick façade on the entire the perimeter of the façades. Restoration of metal balcony, changing of the doors and windows, restoration of decorative elements and installation of decorative lights is also envisaged under the design.

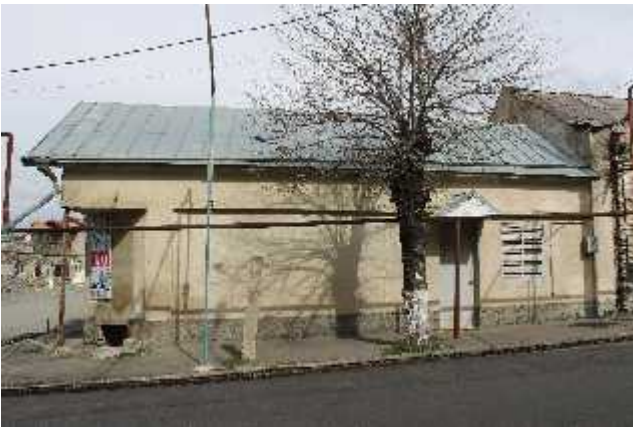
The SP includes to repair the damaged parts of facade and painting works.

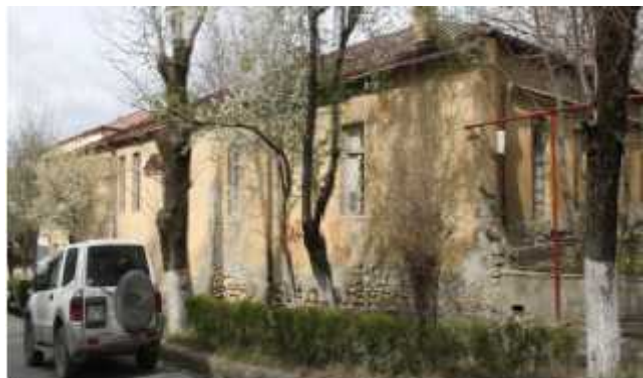
SP envisages full rehabilitation of the building façade from Rustaveli Street. Main rehabilitation works are as follows: dismantling of existing doors, windows and

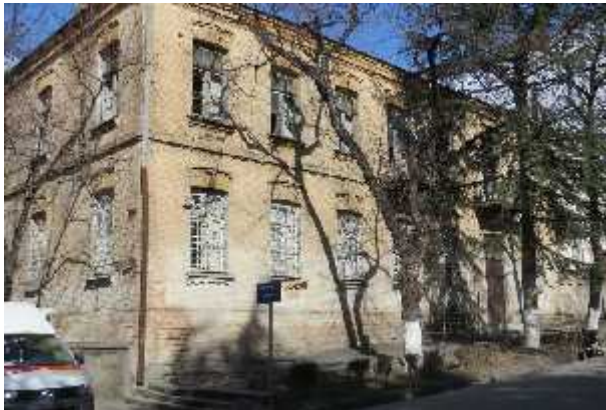
Two gates of honour represented on the facades will be replaced with new ones which will be similar to existing doors. Amortized wooden items, wooden balconies on both floors and wooden staircases will be removed and arranged again. The amortized roof cover and the main gate of the courtyard will be replaced; the metal staircase will be repaired. In the inner courtyard on the entire perimeter of the building and along the fence will be arranged concrete waterdrain which will protect the building from the rains.
