# **Urban regeneration of historical streets in Dusheti**

## **Environmental Review**

**Third Regional Development Project**

**January, 2018**

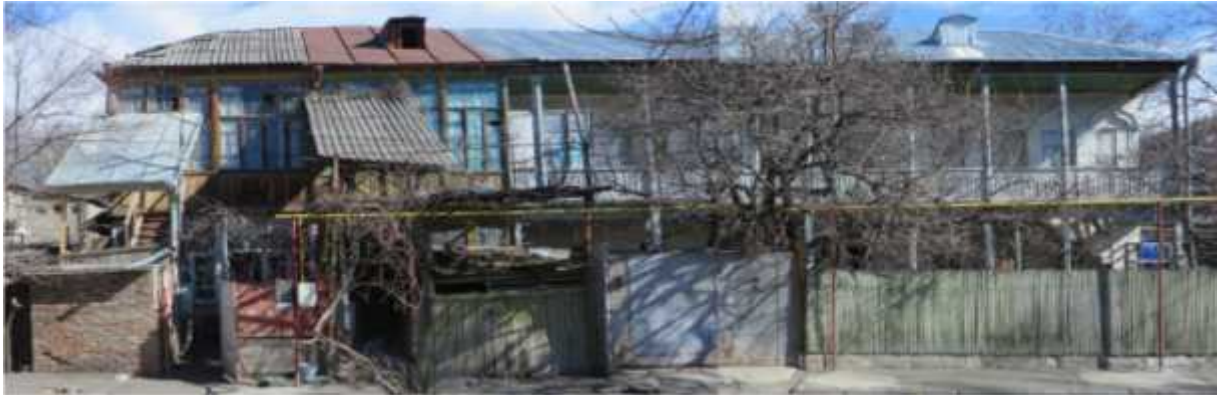
The SP envisages rehabilitation of the building façade of the house #1 and #3 on Erekle II Street and replacement of its roofing.

In particular, the design includes repairing and restoration of the façade plastering, replacement of the doors and windows, replacement of the wooden balconies and glass gallery with the new ones along the entire perimeter of the façade, arrangement of wooden staircases accessing to the balconies. Also, dismantling of the existing brick and wooden fences around the courtyard and the metal gate, and arrangement of new fence with mixed brick and stone masonry. Wooden planks and tin cover of the roof will be replaced by the gray color tin sheets.

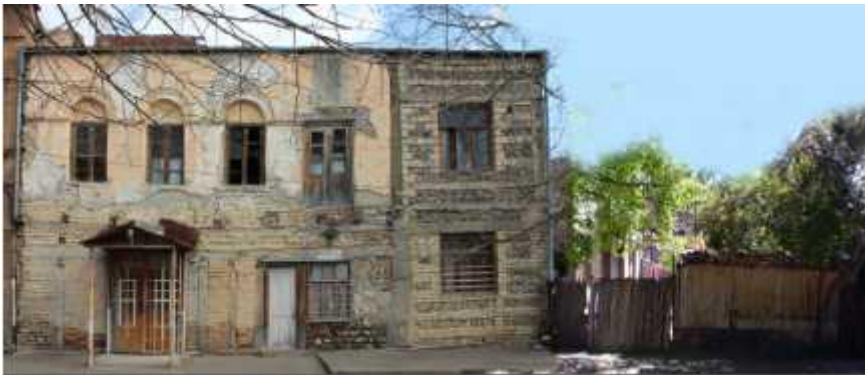
The SP includes rehabilitation of the house facade and roof replacement. In particular, cleaning of

the façade from existing plastering, replacement of doors and windows, re-built a wooden balcony (similar to balcony of the house on Erekle II Street # 9) from Erekle II street side.

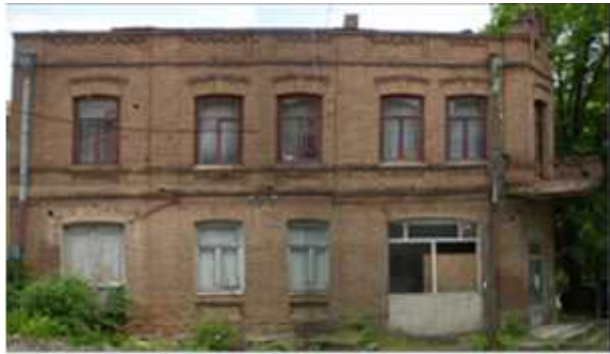
The project includes rehabilitation of the building facade, replacement of roof, restoration of the

outside decorative wooden balconies and replacement of doors and windows with new ones. Rehabilitation of facades includes cleaning of brick-work using sand jet blower, restoration of damaged areas, cleaning of forged balcony from existing paint and its

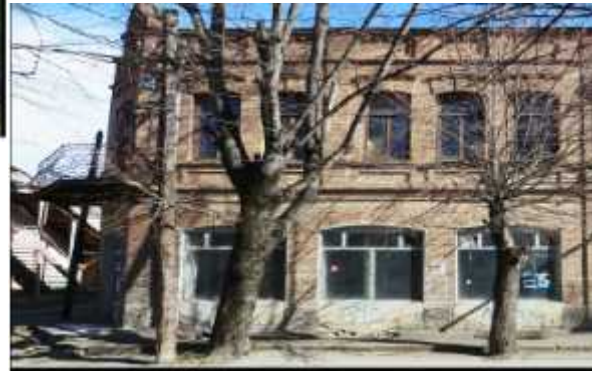
painting, restoration of the wooden decorative elements from the yard, and replacing of the missing part with the new one, dismantling of the ugly staircase going to the second and arrangement of new wooden one using the existing wooden decorative elements. The wooden planks and tin cover will be replaced with new one.

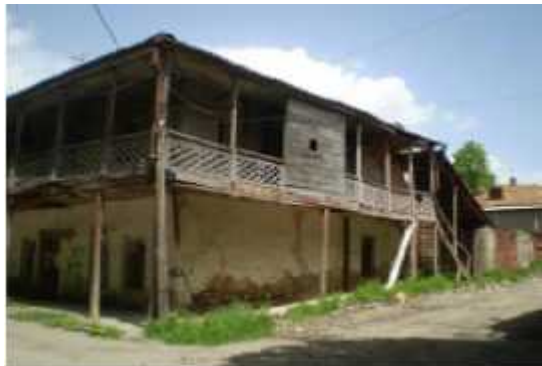
## #9 and #11 Erekle II Street (Cultural Heritage Monument)

The Houses located on Erekle street #9 and # 11 actually are one building.

House located on #11 Erekle II Street is a two-storey building with wooden balconies along the entire facades of the building. The total area of the façade is 126 m<sup>2</sup>, the total area of the roof is 225 m<sup>2</sup>. The project considers removal of the existing façade plating and its re-plastering, repairing-resoration of the plastered cornices, replacement of the doors and windows, and wooden balcony on the entire length of the facade, arrangement of the stained glass windows and repairing of the balcony from the yard side (replacing damaged

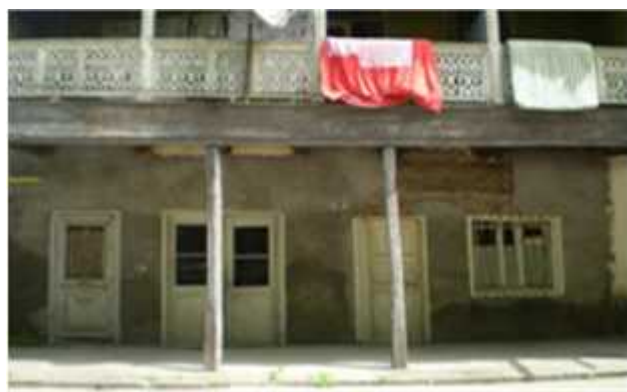
elements) on the first floor, replacement of wooden planks and tin cover of the roof (tile and dark tin sheets).

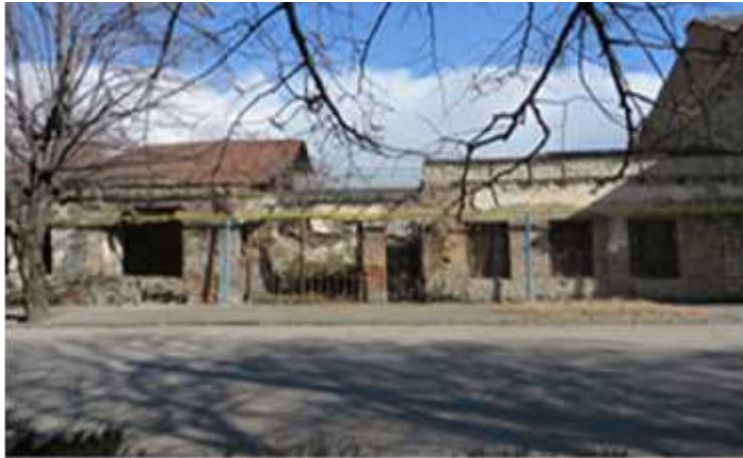
The house is a one-storey brick building with a basement. The inner courtyard divides the building into two blocks. The right block is a residential home. The SP envisages rehabilitation of façade and replacement of roof cover. The façade rehabilitation works includes clearing of brick arches from fragments built with block and silicate brick, as well as changing the silicate brick parapet with the Georgian brick parapet. There will be arranged wooden stained glass windows inside the brick arches. The left block of the building is practically demolished. The SP envisages: cleaning of the building and yard from garbage and shrubbery; Reinforcement of some parts of the walls and rebuilding of the others, arrangement of the

reinforced concrete roofs between the floors and staircase entering down to the basement; Restoration of damaged arches and brick parapets; Arrangement of roof with wooden structures that will be covered with gray tin sheets, the roofing cover will be changed in the right block of the building as well; The metal gate will be replaced with new one; fortified and re-built walls will be plastered with sand-cement mortar (in the interior), in the restored brick arches the wooden stained glass windows will be arranged.

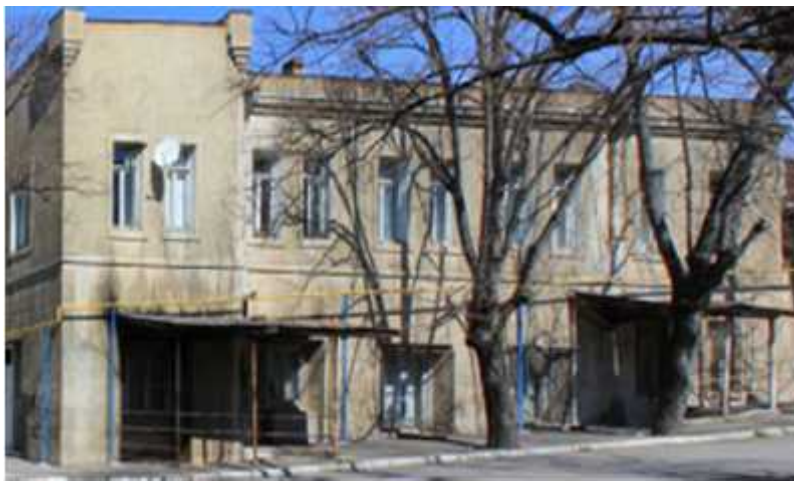
The SP envisages replacement of the roof, refurbishment of the library (occupies 214.2 m<sup>2</sup> in the building) and Free Dining Hall of Dusheti Municipality for the People Deprived of Care (occupies 144.5

m<sup>2</sup> in the building), replacement of doors and windows with the new ones. Rehabilitation of the facades includes its cleaning with sand jet blower, restoration of the damaged parts, rebuilding the balconies with metal railing (presumably these balconies existed in the past). The library book stack needs repairing of walls, ceiling and floor. Damaged

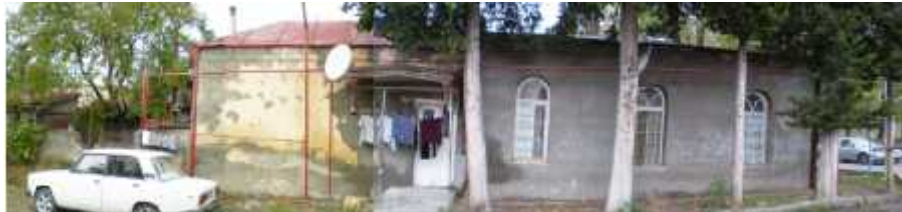
The SP envisages rehabilitation of the façade and the replacement of the roof, namely: cleaning the façade

from the remained plastering, restoration of plastered cornices, replacement doors and windows and canopies; dismantling the yard fence and metal gate and arrangement of new block fence and installation of metal gate, replacing wooden planking and tin cover of the roof.

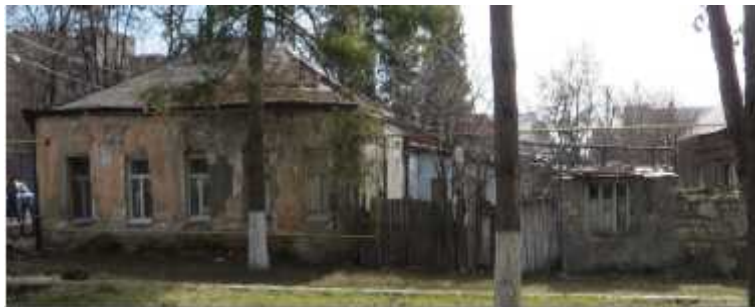
### **#32 Kostava Street (Cultural Heritage Monument<sup>2</sup>)**

The SP envisages the rehabilitation of the building façade and the replacement of the roof, namely: cleaning the façade from the remained plastering, restoration of plastered cornices, replacing doors and windows and canopies, dismantling of fence of the yard and the metal gate and

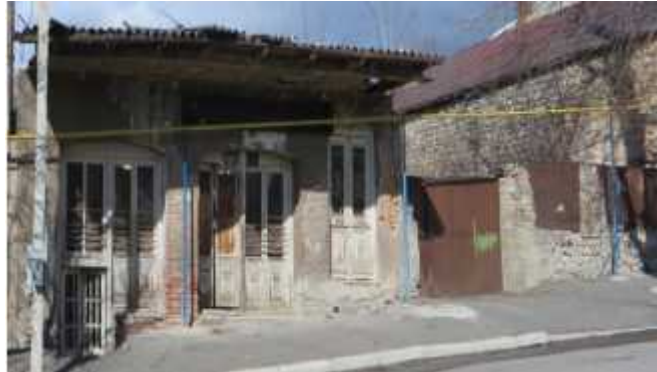
### **# 14 St. Ninos Street (Cultural Heritage Monument<sup>3</sup>)**

The house is a one-storey brick building with a basement that is damaged currently. The SP implies the following works: Restoration of the building and clening of yard from the rubbish and shrubbery. Some part of retining wall will be strengthend and other part rebuilt floors, between the floores the reinforced concrete slabs will be arranged, staircase leading down to the basement will be arranged, existing plaster from façade and inner walls will removed. A new roof with woodens structures will be arranged that will be covered with gray tin sheets, metal gate and fence will be replaced with new one, some part of the doors and windows will be restored and other replacemed with new ones, strengthened and rebuilt walles and filled walls of will be plastered with sand-cement mortar.

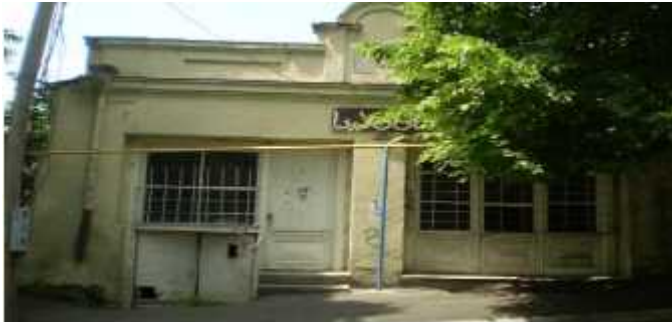
### **#16, #18 and #20 St. Ninos Street**

The SP envisages restoration of facades and replacement of the roofs of the houses #16, #18 and #20 St. Nino Street.

At present, the **house # 16 (Cultural Heritage Monument<sup>4</sup>)**, is a one-storey with a basement, and requires repair and restoration of the façade of and plastered cornices, replacement doors and windows, and restoration of staircase passing to the facase and leading down to the basement (basalt slabs).

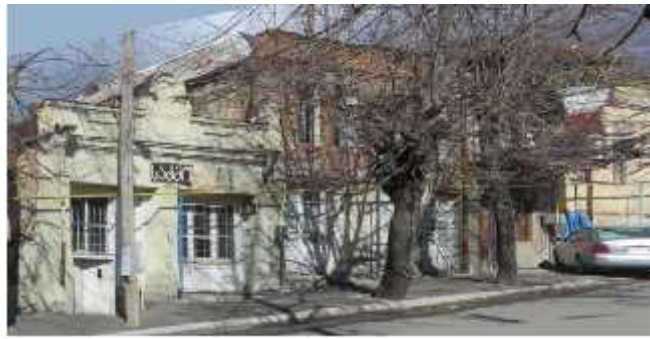
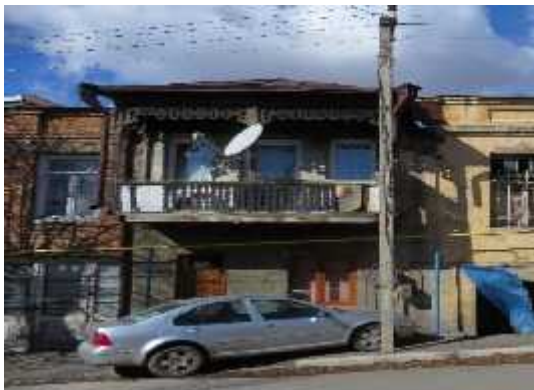
**The house # 18** represents the two-storey brick building, the first floor of which is poorly plastered and on the second floor is provided an ugly masonry. The project envisages removal of façade bad-quality plaster, plastering of entire façade with sand-cement mortar, replacement of doors and windows and restoration of stair steps.

**House # 20 (Cultural Heritage Monument<sup>5</sup>)** - Two-storey brick building with wooden balconies. The entire façade will be cleaned from poor quality and damaged plaster, the doors and windows will be replaced, the open balcony will be restored (the most part of the balcony will be replaced with new ones), the facade will be plastered with sand-cement mortar. Roof planks and gray tin cover of all three houses will be replaced. There will be arranged a basalt socle on the façade.

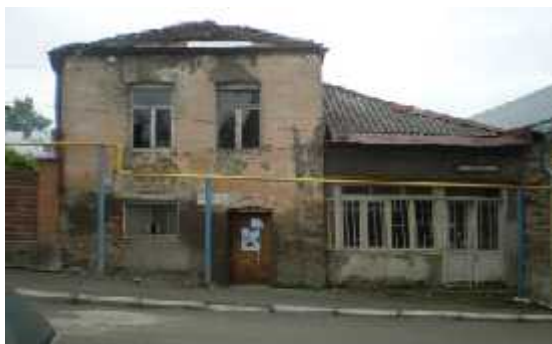
#### **# 19 St. Ninos Street**

The SP includes rehabilitation of building façade and replacement of the roof. As of today, one part of a House # 13 is a two-story and the other part – one-storey. The SP provides works for removal of bad-quality plaster and re-plastering of entire façade of the building with sand-cement mortar. Replacement of doors and windows and restoration of stair steps. The roof planking and tin cover will be replaced with gray color tin sheets.

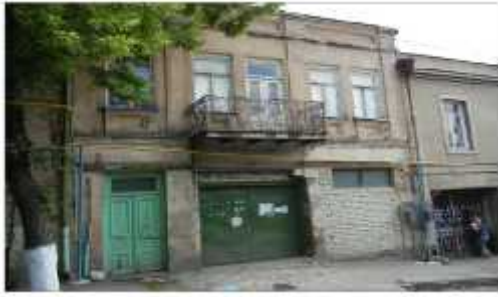
**House # 39 (Cultural Heritage Monument<sup>6</sup>)** The SP considers removal of existing plastering, re-plastering and painting. Replacement of roof rainwater drainage pipes on the roof; Restoration of doors and windows on the second floor and the main entrance door on the first floor. Replacement of large door and window on the first floor, finishing of the stair with basalt tiles at the main entrance of the building, cleaning and painting of the balcony railing.

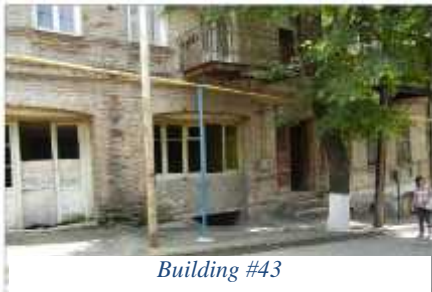
*Building #43*

**House # 43-41 (Cultural Heritage Monument<sup>7</sup>)** is a two-storey brick building with a basement. The SP envisages rehabilitation of the façade, replacement of doors and windows in the basement and on the first floor of the building, doors and windows on the second floor will be restored, new stained glass windows will be installed and main entrance door restored. The entrance stairs will be finished with

basalt slabs. The balcony railing of the house # 43 will be cleaned and painted. On the balcony of # 41 balcony railing similar to house # 43 balcony railing will be installed and painted.

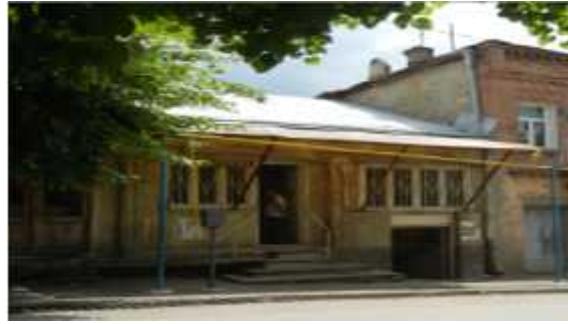
**House # 51 (Cultural Heritage Monument<sup>8</sup>)** is a one-storey building with a basement which is built with brick. The SP includes rehabilitation of the façades, rearrange of shad of the building, replacing of stained-glass windows, doors, windows and the basement door, also finishing the stair at the entrance with basalt slabs.

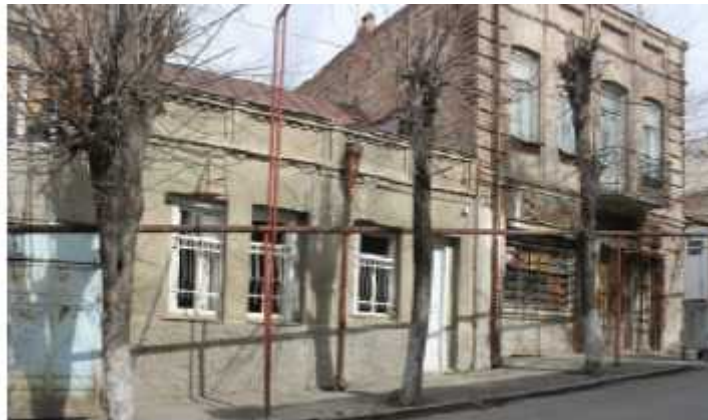
#### **# 68 Shota Rustaveli Street**

House is a one-storey building. The SP envisages rehabilitation of the building entire façade from Rustaveli Street. The following works will be implemented within the SP: dismantling of existing doors, windows and grilles; Removal of old tin cover from the roof and water drain pipes; demolition of damaged wooden structures; Cleaning the façade from old plastering using sand-Jet machine. The reconstruction works include: restoration of damaged wooden structures of the roof, arrangement of roof cover and water drain system; Restoration of the damaged façade revealed after old plaster removal; Installation of wooden doors and windows with metal grilles; inside the new door a simple profile staircase with basalt slabs will be arranged. Repairing and restoration parts of interior (engineering elements) damaged during the demolition works.

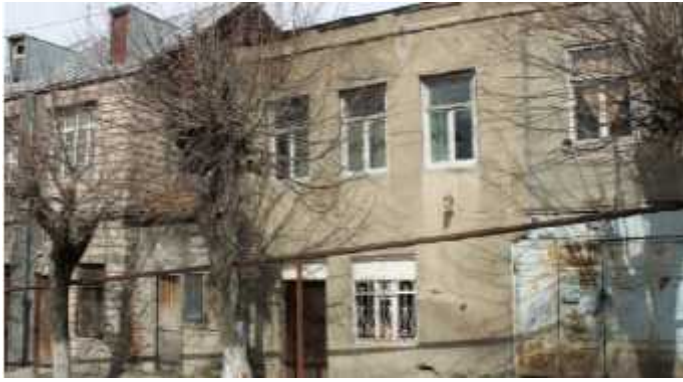
#### **#70 Shota Rustaveli Street**

dismantling the existing doors, windows and metal gate; removing the rebuilt parts of doors' and windows' openings on the first floor; removing the old tin cover of the roof and the water drain pipes; dismantling the damaged wooden structures and plancking of the roof; Cleaning the façade from old plaster using sand-jet machine. Reconstruction works include: restoration of damaged wooden

structures of the roof; Restoration of earlier parametres of the gate; installation of new roof cover (gray color) and water drain system; Restoration of façade damaged elements identified after the removal of old plaster; Installation of wooden doors and windows; Installation of metal gate, façade plastering with sand-cement mortar and painting; Arrangement of a simple profile staircase with basalt slabs in front of the new door.

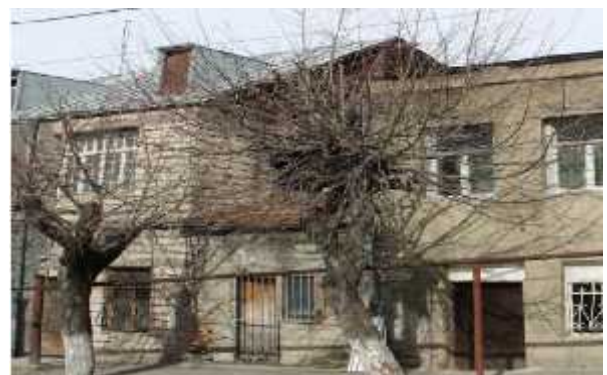
### **#72 Shota Rustaveli Street**

There are two buildings on this address. One of them is two-storey building with attic and has a one-storey building attached on it. The SP envisages full rehabilitation of the building façade from the side of Rustaveli street. The SP considers the dismantling of the existing doors, removal of the old tin cover from the roof and the water collecting pipes, removal of damaged wooden structures and plancking of the roof, cleaning the façade from the old plastering with sand-jet blower, restoration of damaged wooden structures on the roof; Arrangement of roof cover and water drain system; Restoration of the damaged façade which was revealed after the removal of the old plastering; reconstruction of the attic incomplete wall and façade plastering with sand-cement mortar. Installation of wooden doors and windows; plastering the façade with sand-cement mortar and painting, setting a simple profile staircase with basalt slabs in front of the new door.

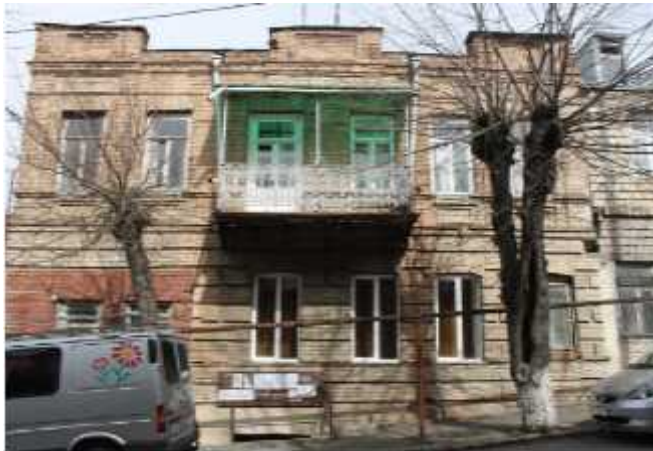
### **#74 Shota Rustaveli Street**

The artistic value of the building is quite high and it plays an important role in creating of visual appearance of the street. According to the SP the rehabilitation of the building façade will be carried

out from Rustaveli Street. The reconstruction works include: dismantling of existing doors, windows and grilles, metal structure of balcony overlap and wooden floor; Removal of old tin cover of the roof and water drain pipes; Removal of damaged wooden structures of the roof; Clearing the façade from old plater (basement) using sand-Jet machine, restoration of roof damaged wooden structures; Arrangement of new roof cover and water drain system; Restoration of the

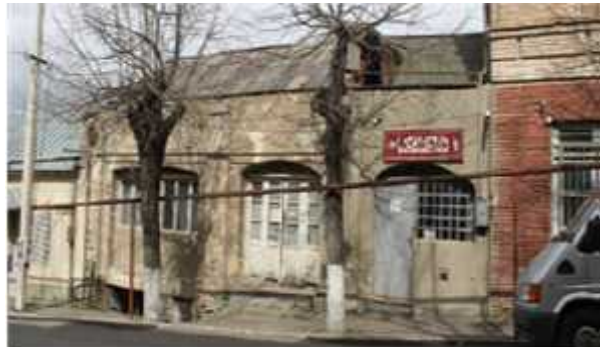
### **#76 Shota Rustaveli Street (Cultural Heritage Monument)**

The SP considers demolition of façade damaged elements and dismantling of the existing tin cover and damaged wooden structures of the roof, doors and windows, clearing the staircase accessing to the basement, dismantling the railing, demolition of basement wall, cleaning the façade with sand-Jet blower; restoration of wall damaged fragments, Installation of doors and windows, facades' plating with sand-cement mortar, installation of wooden structures and the new roofing cover with gray tin sheets of the roof, and water drain pipes, painting the doors and windows, arrangement of metal railing, basalt stair steps, staircase of leading down to the basement and its painting.

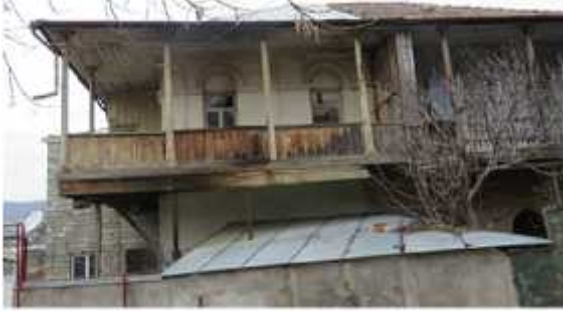
Aprilov House is located in the corner of Dadiani and Shamanauri streets. The SP includes the following works: Rehabilitation of the roof – entire replacement of the roof cover and planking, arrangement tile roofing on the building and tin cover on the balcony, fragmental strengthening of the roof wooden

structures, rehabilitation of the balcony and glass gallery – rearrangement of wooden columns and railings, fabrication and installation of new wooden rail post and windows glass gallery. Complete replacement of ceiling planking and floors of the balcony. The replacement of doors and windows is not provided by the project. They will be cleaned, processed and painted with oil

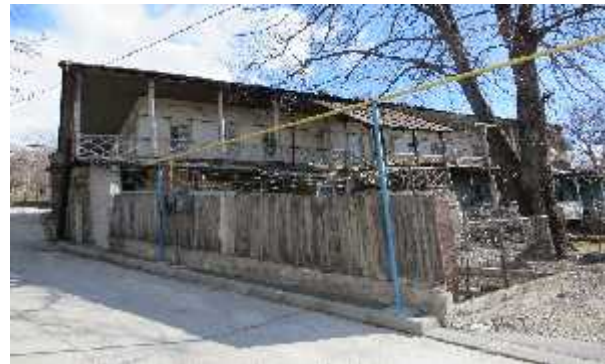
### **Ilia Chavchavadze's house (Cultural Heritage Monument <sup>10</sup>)**

The building is located on Theater Street in which some time lived Ilia Chavchavadze, the famous Georgian writer and political figure. Currently, the building is amortized and needs necessary and urgent rehabilitation works. The SP envisages restoration of the exterior appearance, which includes rehabilitation of the facades, restoration of wooden units and decors of glass gallery and windows and doors of façade. All wooden items, decors, doors and windows will be processed and painted with oil paints.

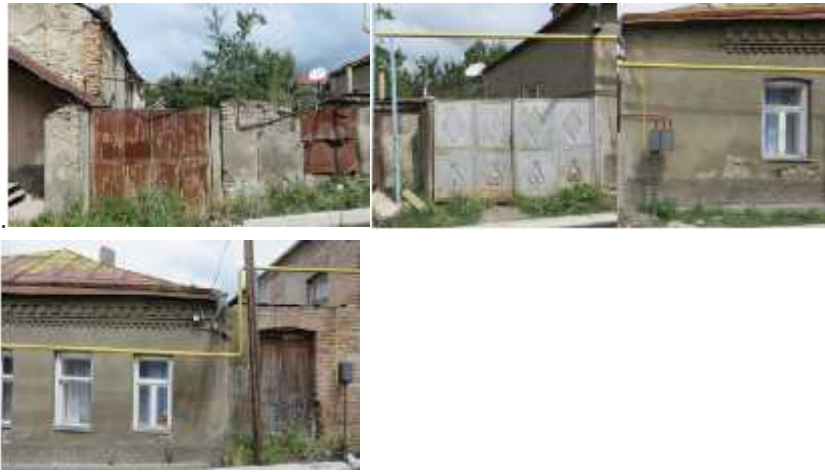
The rehabilitation works of the **house # 8** includes restoration of brick facades and cleaning with sand-jet blower. Also, along the rehabilitation perimeter the fence and 3 new wooden gates will be arranged and 1 door rehabilitated.

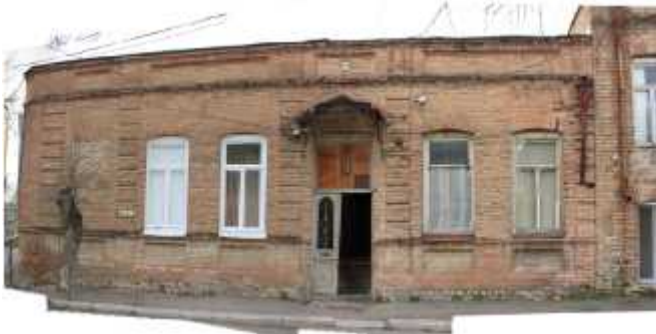
### **#10 Ilia Chavchavadze Street (Cultural Heritage Site<sup>11</sup>)**

The one-storey building built with old Russian brick is located on the intersection of Shamanauri and Chavchavadze streets and façades comes out on the both streets, the building has a basement and a

low parapet on the both sides of the street, it is covered with usual black tin.

The SP envisages removal of the existing roof and arrangement of the dark tin sheets on the new wooden structure; Cleaning of the façade using sand-jet blower, replacing of the existing doors and windows with new wooden doors and windows, restoration of the entrance

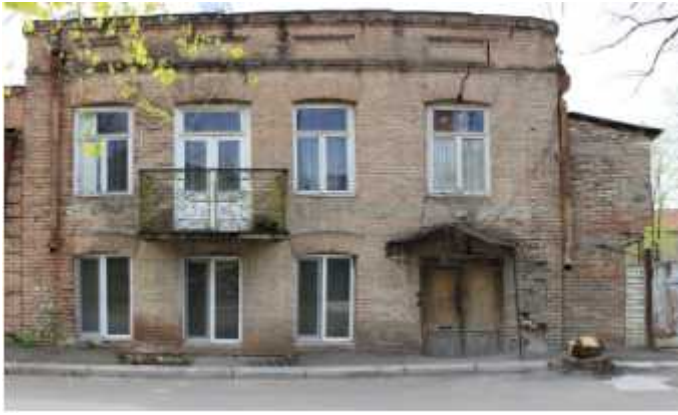
### **# 6 Nazi Shamanauri Street (Cultural Heritage Monument)**

House is a two-story building, constructed with Old Russian brick and covered with ordinary black tin. The project envisages replacement of existing roof and arrangement of dark tin roofing. Replacement of wooden doors and windows, restoration of the wooden entrance door in its original form. The later rebuilt part will be rearranged with new metal structure, which will strengthen the cracked wall, the exterior

damaged parts of the brick wall from the street will be plastered and façade will be cleaned with sand-jet blower, gate from the Shamanauri street side will be replaced, damaged part of the wooden balcony will be cleaned, the damaged wooden structure of the balcony changed and strengthened with new wooden columns on the both floors. Structures and details of the wooden balcony also will be restored.

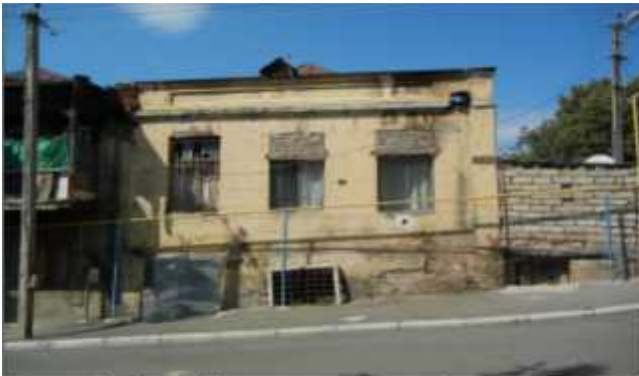
#### # 22 Nazi Shamanauri Street(Cultural Heritage Monument<sup>12</sup>)

The one-storey brick building, which is later plastered, is located on Shamanauri street and its one façade goes out to the St. Nino Street. It is roofed with painted tin cover. The building has a basement and a small yard that is bordered by a fence. The SP includes the following works:

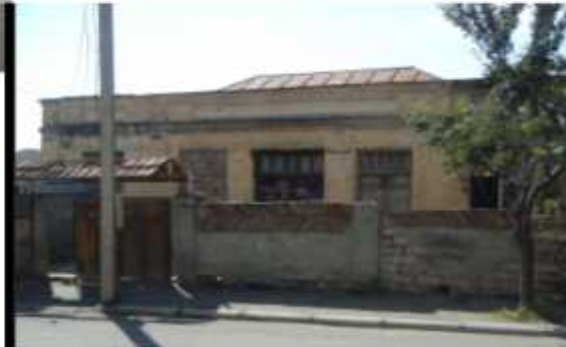
Removal of roof cover and wooden structures, strengthening of brick walls with reinforced concrete belts, arrangement of new ceiling rafter, rafter construction, plancking and tin cover; fence demolition and construction of a new one with brick; the old plastering will be removed from the walls, re-plastered and painted, the wooden doors and

windows on the outer perimeter will be replaced, painted and the original appearance will be returned to building.

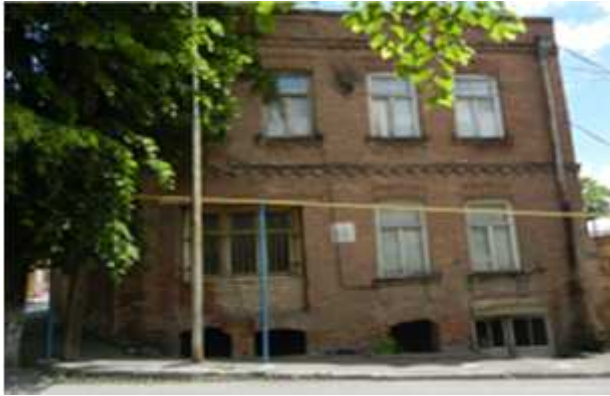
### **# 12 Nazi Shamaauri Street (Cultural Heritage Monumen<sup>13t</sup> )**

The two-storey old brick building is located on the corner of Shamaauri and Rustaveli streets. There is

a large basement in the building which has entrance from Rustaveli Street. The project includes removing of the existing roof cover and arranging a dark tin layer on a new wooden construction of the ceiling rafter. Restoration of demolished parts of the building such as: brick arche and doors at

entrance of the yard, entrance door from Shamaauri Street, arched opening and corner of the building and wooden door of the building. Restoration of stained glass windows on the first floor – cleaning from old paint and re-painting. Cleaning and restoration of damaged brick casing, also of the wooden decorative elements of balcony and staircase. The doors and windows will be completely changed, stained glass windows and basement on the first floor will be cleaned, and parapet will be restored.

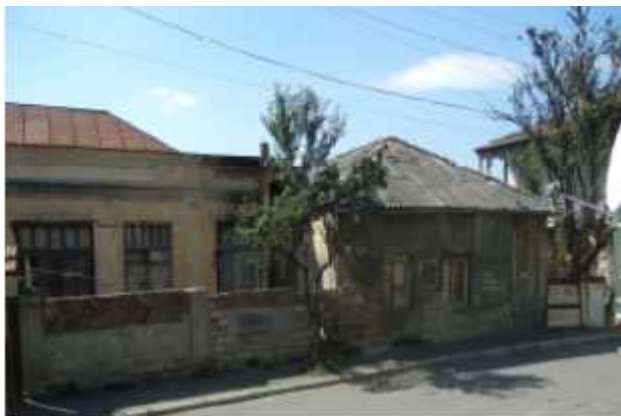
### **#14 Nazi Shamaauri Street**

The house is an ugly one-storey brick building which

later was plastered and covered with curved asbestos sheets. The building is damaged and requires serious constructive works. The SP envisages demolition of the existing roof cover and wooden structures, strengthening of the brick walls with reinforced concrete belts and arranging new roof structures, wood planking and roof cover, balcony with new constructions will be arranged as well, including: reinforced concrete roofing, wooden beams, columns, floor, ceiling and walls of the balcony. Part of the walls will be built with usual red bricks. The new wooden

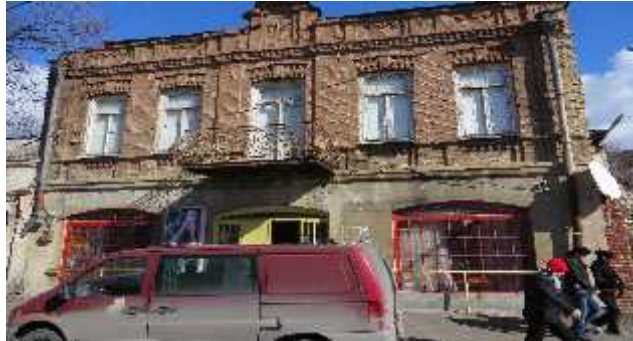
#### **# 55 Nazi Shamaauri Street (Cultural Heritage Monument)**

The house represents the building built with Old Russian brick, with a flat brick arches typical to the town and this street. The SP envisages dismantling of the old roof and arrangement of a dark tin cover on the new structure wooden ceiling rafter, the brickwork of façades on the second floor cleaned and restored, lines between the bricks will be plastered, doors and windows, all brick decorative elements and ornamental iron balcony railing and decorative plastering of the balcony on the first floor restored, there will be arranged wooden stained glass windows and decorative lights.

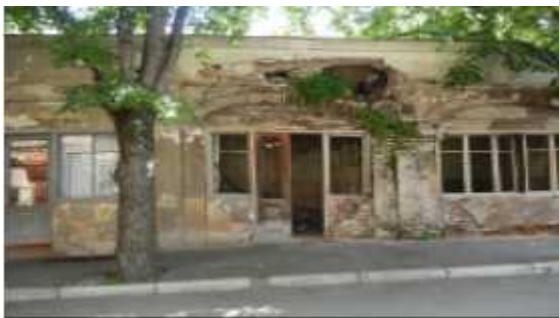
#### **#57 Nazi Shamaauri Street (Cultural Heritage Monument<sup>14</sup>)**

The house is a one-storey brick building, with backyard. In the left corner of the building from the Shamaauri street is located a store, after it is a living area, and in the rest area of the building floors and ceiling is demolished. Building was reconstructed several times and plastered.

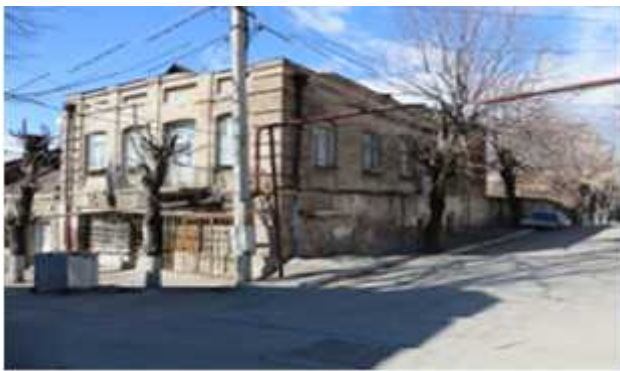
#### **#14 Shota Rustaveli Street**

The two-storey building is built of stone and brick mixed masonry, and which later have been plastered. The second floor is built with brick. The rehabilitation works include removal of the existing roof and arrangement of the dark tin layer on the new wooden structure of ceiling rafter. Removal of cement plastering on the first floor and restoration of the old masonry, cleaning and restoration of the brick façade on the entire the perimeter of

the façades. Restoration of metal balcony, changing of the doors and windows, restoration of decorative elements and installation of decorative lights is also envisaged under the design.

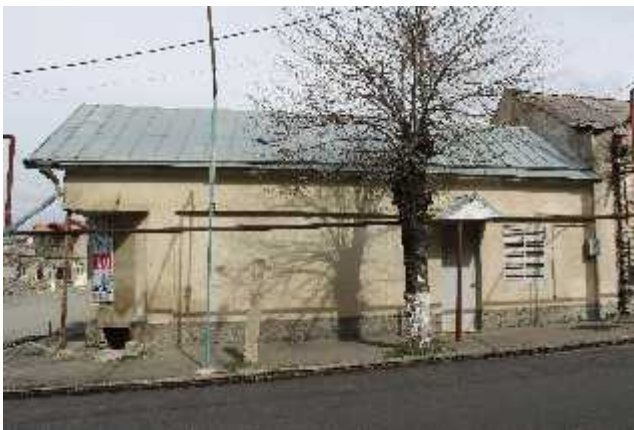
### #19 Shota Rustaveli Street

The SP includes to repair the damaged parts of facade and painting works.

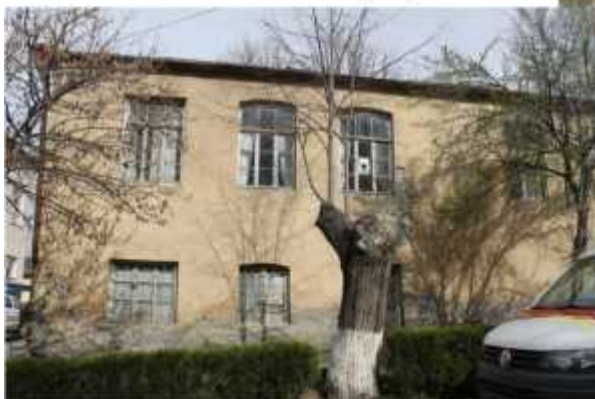
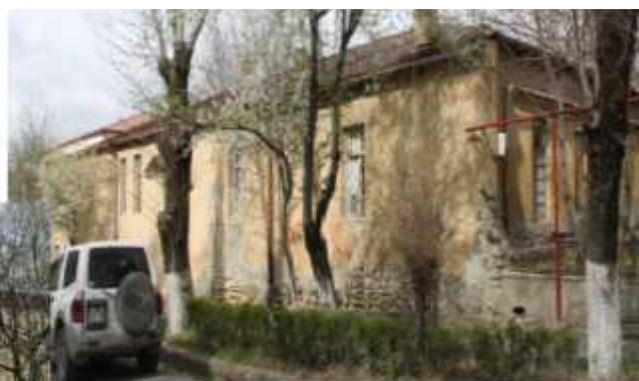
### # 64 Shota Rustaveli Street (Cultural Heritage Monument)

House is a two-storey building built with mixed masonry, a brickwork is around the windows and other part of building built with a stonework. The SP envisages full rehabilitation of the building façade from

Rustaveli Street. Main rehabilitation works are as follows: dismantling of existing doors, windows and grilles; Removal of the old tin roof cover and the stormwater drain pipes; removal of damaged wooden structures of the roof; Cleaning the

façade from old plastering using sand-jet blower, demolition of damaged elements, restoration of wall damaged fragments, installation of doors and windows, façade plastering with sand-cement mortar, installation the wooden structures of the roof and roof cover with gray tin sheets, installation water collecting pipes, painting the doors and windows, arrangement of stair steps with basalt slabs.

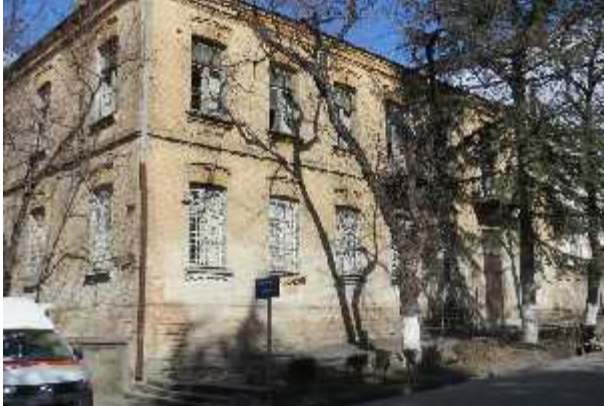
### **# 56 Shota Rustaveli Street (Cultural Heritage Monument)**

Building of the former bank at Rustaveli str. # 56 is a two-storey building built with brick masonry, covered with tile and tin. The SP envisages rehabilitation of the facades and damaged balconies of the building. The facades' rehabilitation includes cleaning of the brick walls sand-jet blower and furnishing works. The the same method will be used for cleaning of brick fence and smoke pipes. Wooden doors and windows are to be cleaned, processed and painted with oily paint.

Two gates of honour represented on the facades will be replaced with new ones which will be similar to existing doors. Amortized wooden items, wooden balconies on both floors and wooden staircases will be removed and arranged again. The amortized roof cover and the main gate of the courtyard will be replaced; the metal staircase will be repaired. In the inner courtyard on the entire perimeter of the building and along the fence will be arranged concrete waterdrain which will
